Intel[®] I/O Controller Hub 7 (ICH7) Family

Intel[®] ICH7 Family Specification Update

October 2009

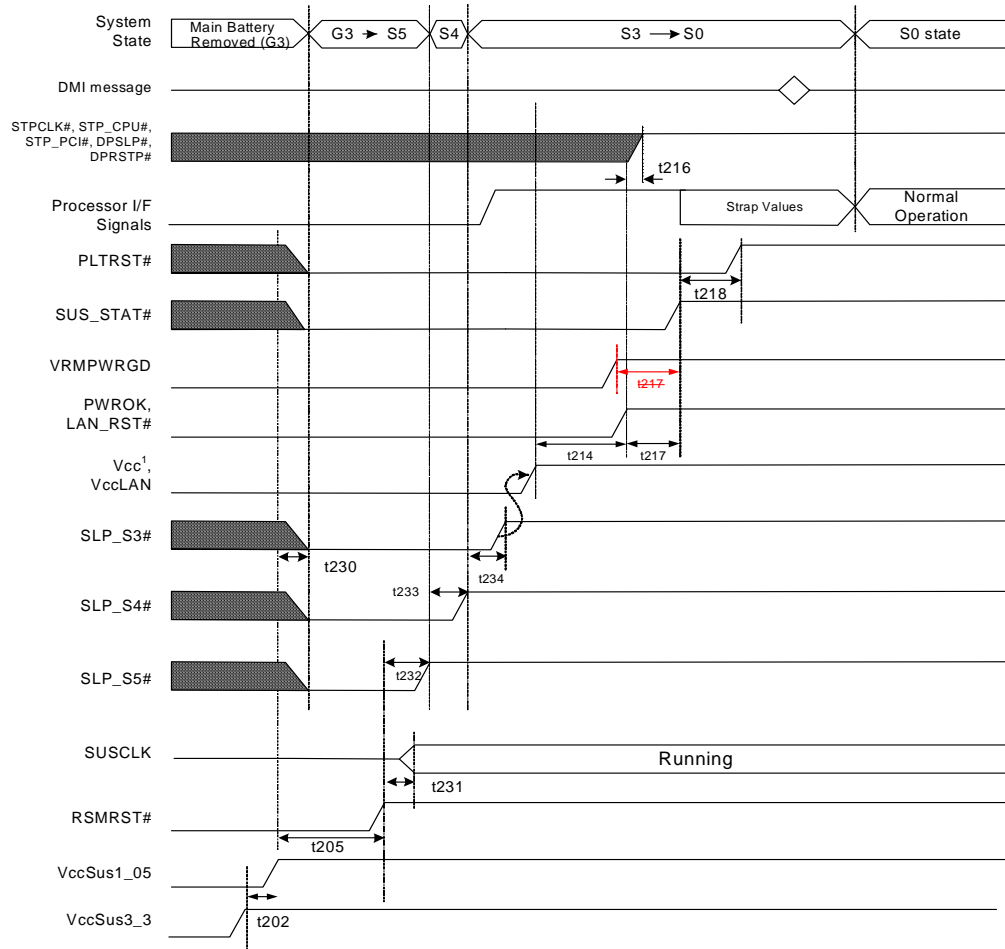
Remove t217 timing that points from VRMPWRGD going high to SUS_STAT# going high from Figure 23-21: G3 (Mechanical Off) to S0 Timings (Mobile/Ultra Mobile Only) in the Datasheet.
