Intel[®] 5100 Memory Controller Hub Chipset

Specification Update

August 2009

Revision 008US

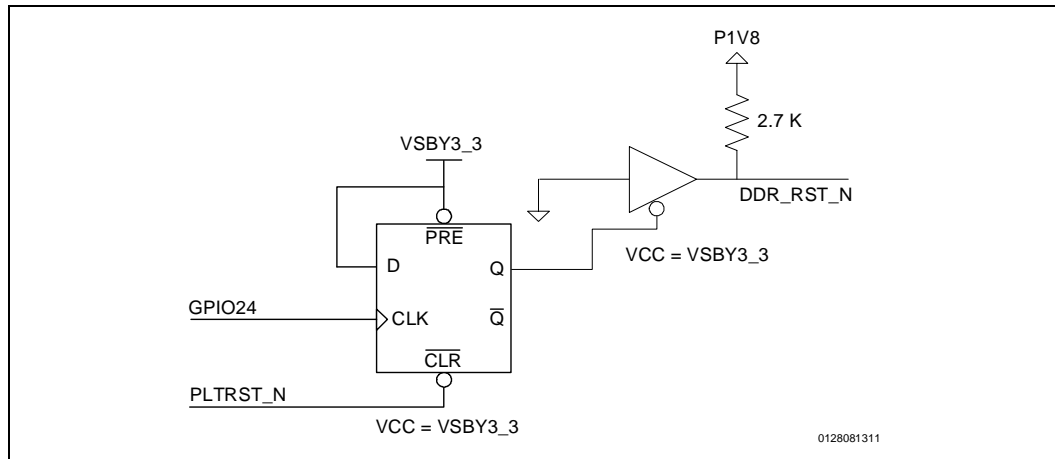
Note: PLTRST_N can be either of the Platform Reset signals PLTRST1_N or PLTRST_N, DDR_RST_N is the DIMM reset signal, P1V8 is the DIMM supply, and VSBY3_3 is the standby 3.3 V supply (optionally VSBY5 standby) as referenced in the Tionesta and Williamsport CRB schematics.

Workaround: The workaround requires both a board-level circuit and a BIOS change. The workaround holds the DIMMs in reset using a flipflop clocked by a GPIO from the ICH9R under control of the BIOS. An output controlled buffer is also required to transition the 3.3 V output of the flipflop to the 1.8 V reset input of the DIMM (see diagram below). The possible GPIOs are GPIO[28,27,24,12]. The GPIO implemented in the circuit is incorporated into the BIOS as a build option by an Intel BIOS Vendor (IBV).

In the example below, GPIO24 is used to clock the flipflop. The GPIO output only controls the DIMM reset during S3 operation; any transitions on the GPIO after S3 exit have no effect on the circuit or the DIMMs Reset signal. The workaround potentially allows the GPIO to be used for other purposes. For more information, refer to either *Platform Design Guide* listed in [Table 2](#); specifically see the “Suspend to RAM (S3) Design Implementation” sections.
