# Intel<sup>®</sup> 5100 Memory Controller Hub Chipset

Specification Update

*August 2009*

**Revision 008US**

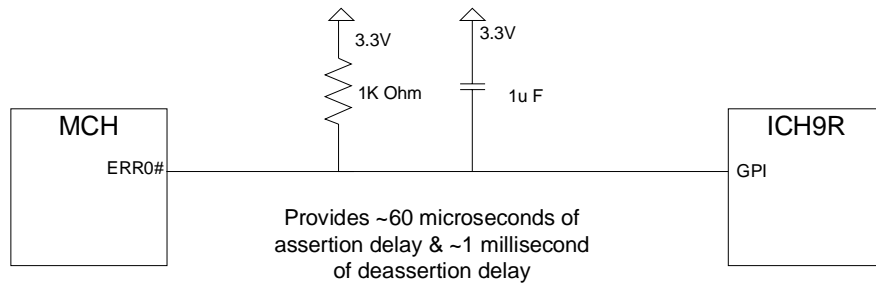
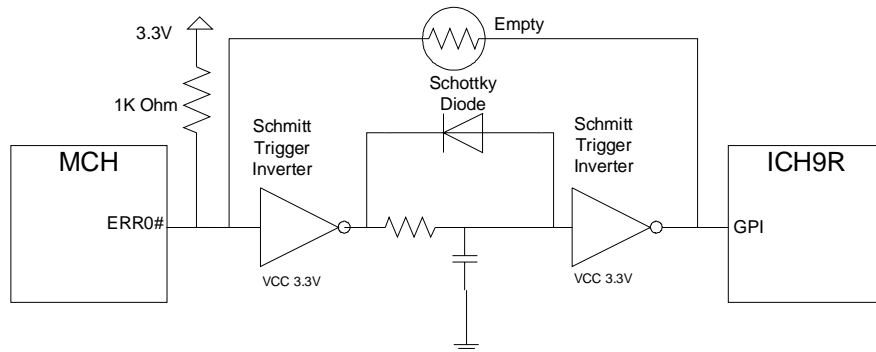
**Problem:** Any condition routed to MCH ERR[2:0]# output pins for SMI# escalation that would result in data poisoning on FSB will result in a CPU IERR# assertion due to race condition. The race condition exists between poisoned data presented to the FSB by the MCH and the uncorrectable error escalated to SMI# via ERR[2:0]# pins. If the CPU observes an SMI# assertion before the poisoned data is presented to the FSB, the CPU asserts MCERR# followed by IERR#. The CPU expects the SMI# assertion to occur at least ten BCLKs after the associated MCERR# assertion. Conditions that result in data poisoning on the FSB are uncorrectable memory ECC errors or poisoned TLPs received from any PCI Express\* port.

**Implication:** CPU may assert IERR# and cause a system hang before the error may be logged in SMM.

**Workaround:** Any one of the three workarounds that have been identified may be selected.

1. Log errors upon reboot
  - System components (MCH, CPU, ICH9R) preserve errors across warm resets via sticky error registers
  - Requires a mechanism to reset system upon IERR# (server management controller, depress system reset button, and so forth)
2. Delay SMI# assertion by inserting a 60–150 µs delay on the ERR0# pin
  - Two recommended circuit solutions (other solutions may be possible):

- Route errors that result in FSB data poisoning to the ERR0# pin (IO4, M1)
- 3. Disable FSB data parity checking on CPU
  - Prevents CPU from asserting MCERR# on poisoned data
