Intel[®] 6300ESB I/O Controller Hub (ICH)

Specification Update

July 2008

Order Number: 300884-013

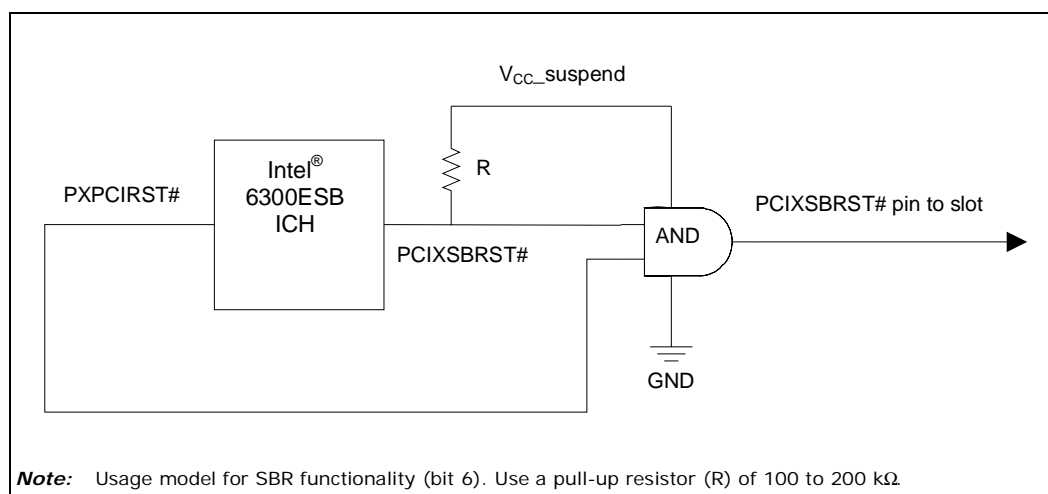
Figure 1. Board Workaround for PCI-X Secondary Bus Reset Functionality

Problem: The Secondary Bus Reset pin (PCIXSBRST#) on the PCI-X bus is internally tied to the Vcc_core well. When the system goes into S3 state (sleep), this signal is floating due to Vcc_core going away.

Implication: System will not WOL when PCIXSBRST# is connected directly to the PCI-X slots.

Workaround: A board workaround pulls the PCIXSBRST# pin up to Vcc_suspend through a resistor (R). This pin is also ANDed with the PXPCIRST# pin so that if the PCI-X bus resets, the signal that is routed to the slot reflects the reset. Also, since the AND signal is powered by Vcc_suspend, when the system goes into sleep state (S3), this voltage is still present and the correct voltage is applied to the signal that is routed to the slot. See Figure 1 below.

Status: No fix. This board workaround is to be used if customers plan to utilize this SBR feature. If not, the PCIXSBRST# pin is to be not connected.
