# 82559ER Fast Ethernet PCI Controller

## Stepping Information

*October 2004*

*Revision 1.1*

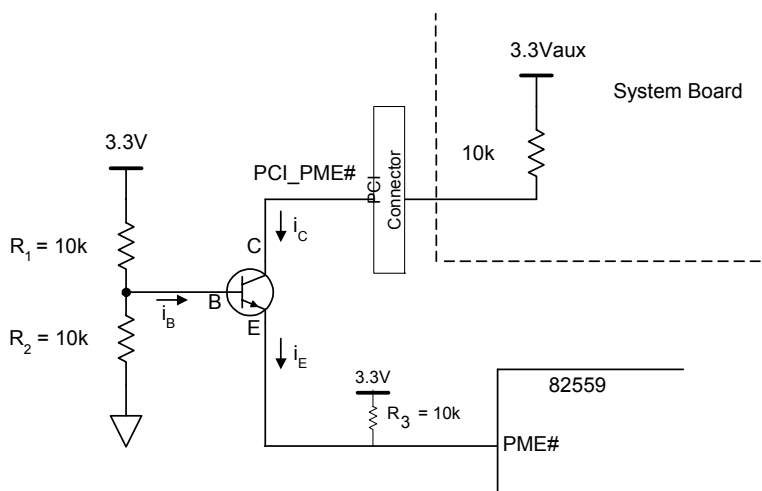
**Problem:** During power cycle events, the electrostatic discharge (ESD) elements internal to the 82559ER may falsely clamp the Power Management Event (PME) output signal to approximately 1.5 volts for 100 ms to 150 ms during initial power up. This can cause wake-up events to be recognized by the system if power management events are enabled in the system chipset. This may result in a problem for mobile environments since the false clamping can cause a suspended system to wake up when the power to the LAN device is transitioned.

**Implication:** The implications of this anomaly depend on the target system configuration. In desktop and server systems, the impact is limited to a false wake-up event occurring when a new card is installed. In mobile systems where the LAN power is transitioned more frequently, the PME signal should be disabled during transitions.

**Workaround:** False PME indications can be avoided by disabling the recognition of a PME before removing or restoring power to the 82559ER. If a hardware solution is required, the following isolation circuit has been proven to be effective. The circuit requires the PCI PME signal (PCI\_PME#) to be isolated from the 82559ER PME signal (PME#). The system does not see the 1.5 voltage level drop caused by the 82559ER's power transition.

**Status:** This anomaly is under evaluation for resolution in future steppings of the 82559ER.
