Intel® 82801DB I/O Controller Hub 4 (ICH4) / Intel® 82801DBL I/O Controller Hub 4-L (ICH4-L)

Specification Update

February 2006

Document Number: 290745-025

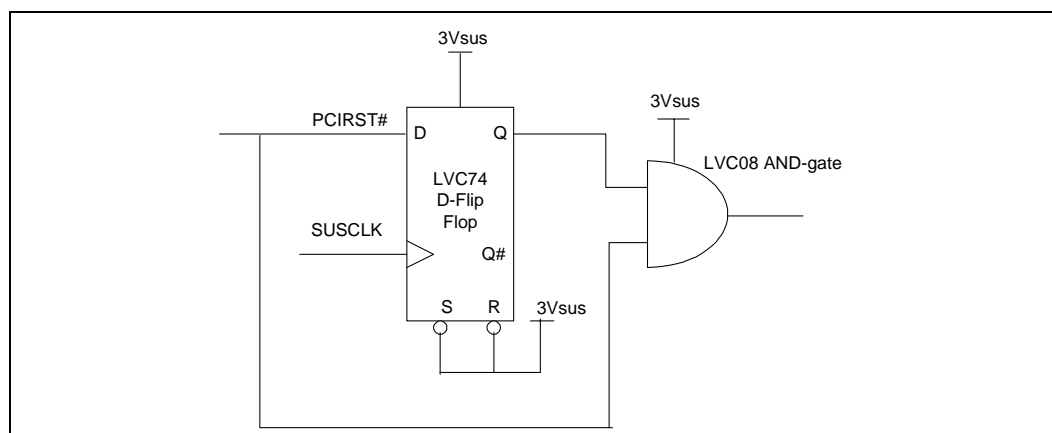
2. Intel® ICH4 LPC Reset Timing

Problem: The ICH4 specified 1–3 RTC timing of SUS_STAT# inactive to PCIRST# inactive violates the LPC Specification (Rev 1.0) of “at least 60 μ s.” LPC Specification Rev 1.1 is not violated by this erratum.

Implication: Some LPC devices may not properly reset resulting in failure of the system to boot or resume from a sleep state.

Workaround: Use any one of these three workarounds:

1. Delay PCIRST# by 1 SUSCLK using a D-flop and an AND gate to the LPC devices.
