# **Intel® 82801DBM I/O Controller Hub 4 Mobile (ICH4-M)**

**Specification Update**

***September 2006***

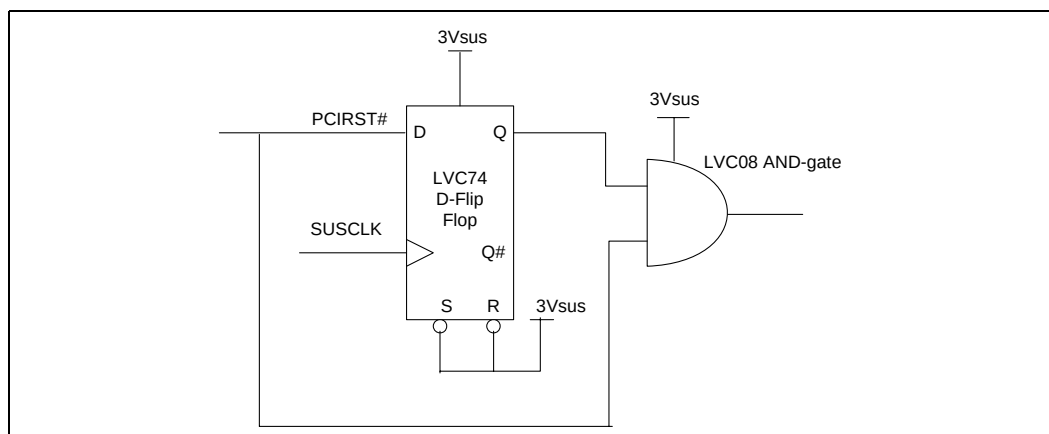
**Problem:** The ICH4-M specified 1–3 RTC timing of SUS\_STAT# inactive to PCIRST# inactive violates the LPC Rev 1.0 specification of “at least 60  $\mu$ s.”

**Implication:** Some LPC devices (based on LPC Rev 1.0) may not properly reset resulting in failure of the system to boot or resume from a sleep state.

1. Delay PCIRST# by 1 SUSCLK using a D-flop and an AND gate to the LPC devices.
