Monthly Specification Update

Intel® Server Board S500VSA SATA

Intel Order Number E57949-004

November, 2009

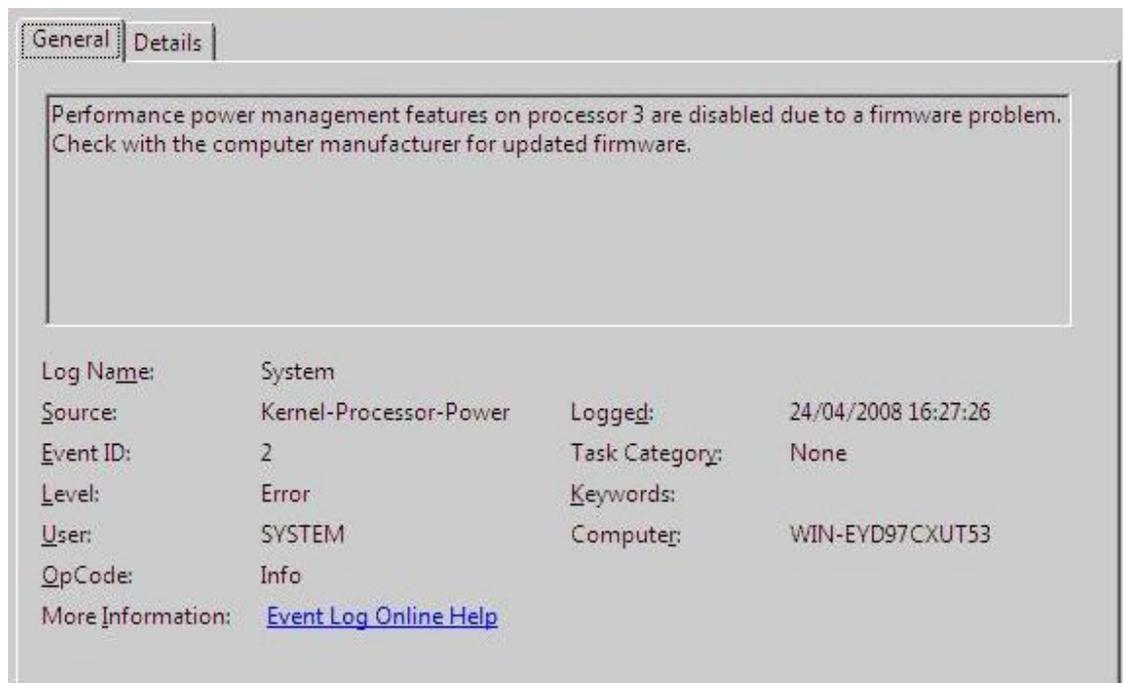
Problem: If you use any Intel® Xeon® Processor of the 5300 or the 5400 series in the Intel® Server Board S5000VSA and install Microsoft Windows Server 2008* on the system, you may encounter the following error in the Windows* event log:

The Event Error is generated due to a change in Microsoft’s validation and logging of supported P-States for a processor. The wording of the error is misleading. There is no performance impact. Microsoft is logging the error because the BIOS has a default PSS object (P-State info) in the ACPI space for these processors. Basically, this default PSS object indicates no P-State is supported. However, Microsoft Windows Vista* and Microsoft Windows Server 2008* have changed the interpretation of this table.
