Intel[®] Server Board S500XVN

Specification Update

Intel Order Number D72472-001

September 2009

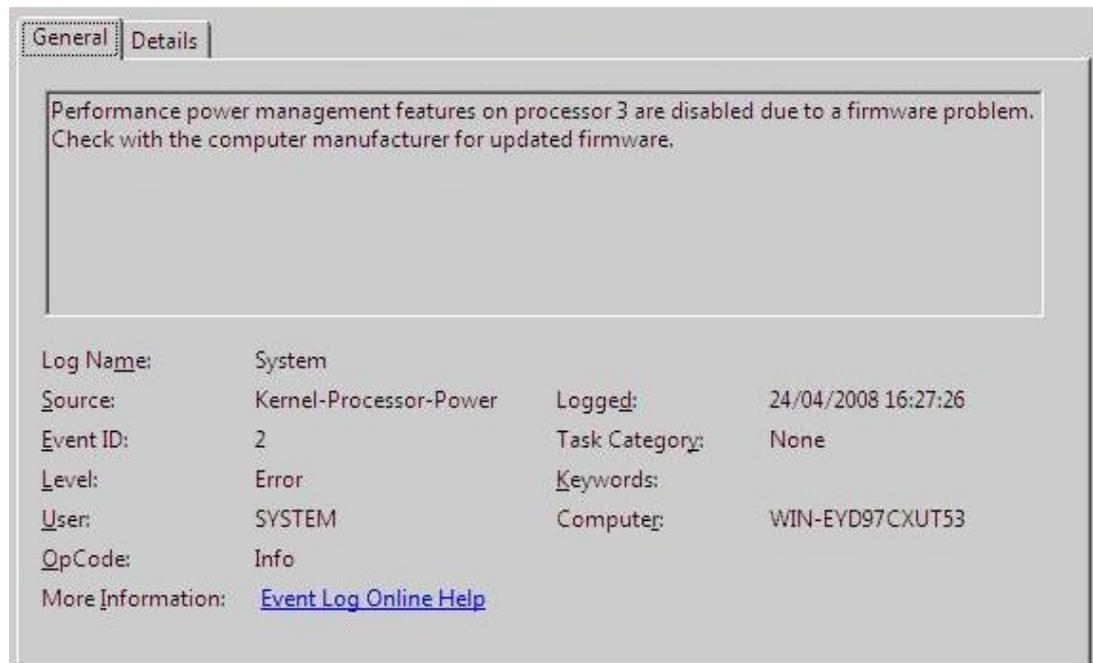
52. Microsoft Windows* Server 2008 and/or Microsoft Windows Vista* may report Performance Power Management error

Problem	Microsoft Windows* Server 2008 and/or Microsoft Windows* Vista in Intel® Server Board S5000PSL and/or Intel® Workstation Board may have a Performance Power Management error in Windows* System Event Log like the following illustration:
---------	--

Implication	Current version of BIOS displays a default dummy PSS object (P-State info) in ACPI space for processors that do not support Enhanced Intel® SpeedStep® Technology to indicate no P-State supported; however, this is interpreted as a
-------------	---

Performance Power Management error in the Operating System log. This is a harmless message and does not impact system performance or functionality.
