Intel[®] Celeron[®] Processor Specification Update

Release Date: August 2007

Document Number: 243748-051

The Intel[®] Celeron[®] processor may contain design defects or errors known as errata, which may cause the product to deviate from published specifications. Current characterized errata are documented in this Specification Update.

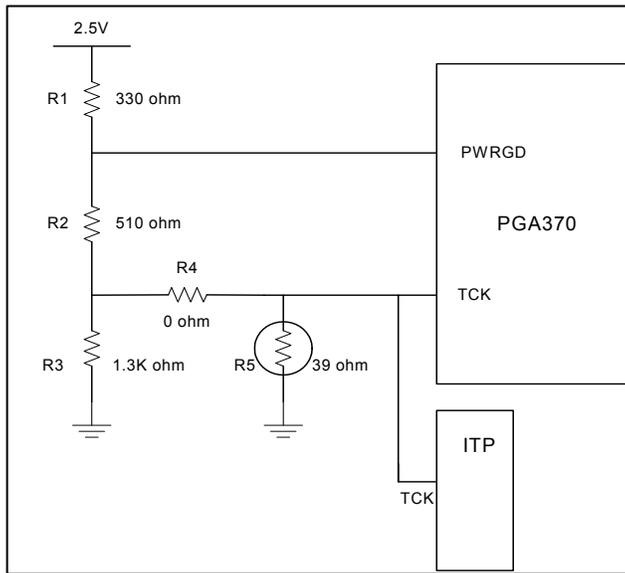
Figure 1 Celeron® on 0.13 Micron Processor 256K Platforms Workaround

In addition, the example workaround circuits shown do not support production motherboard test methodologies that require the use of the processor JTAG/TAP port. Alternative workaround solutions must be found if such test capability is required.

For Production Boards:

Depopulate R5
