Mobile Intel® Celeron® Processor on .13 Micron Process in Micro-FCPGA Package

Specification Update

October 2005

Document Number: [251309-028](#)

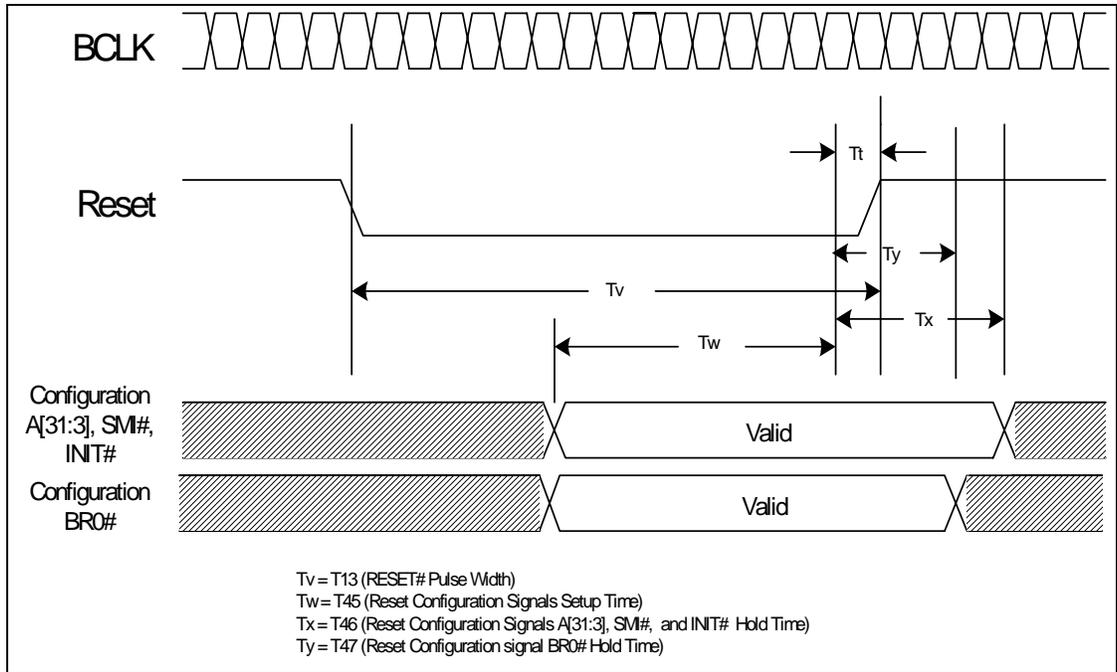
Figure 12. System Bus Reset and Configuration Timings

The BR0# maximum hold time has changed to 2 BCLKs. This change will be shown in the “System Bus AC Specifications (Reset Conditions)” table and “System Bus Reset and Configuration Timings” figure of the *Mobile Intel® Celeron® Processor on .13 Micron Process in Micro-FCPGA Package Datasheet*. This change will be incorporated in the next revision of the datasheet.

The following figure will be modified to reflect this change:
