Intel[®] 82576EB Gigabit Ethernet Controller Specification Update

LAN Access Division (LAD)

Revision 2.85
September 2012

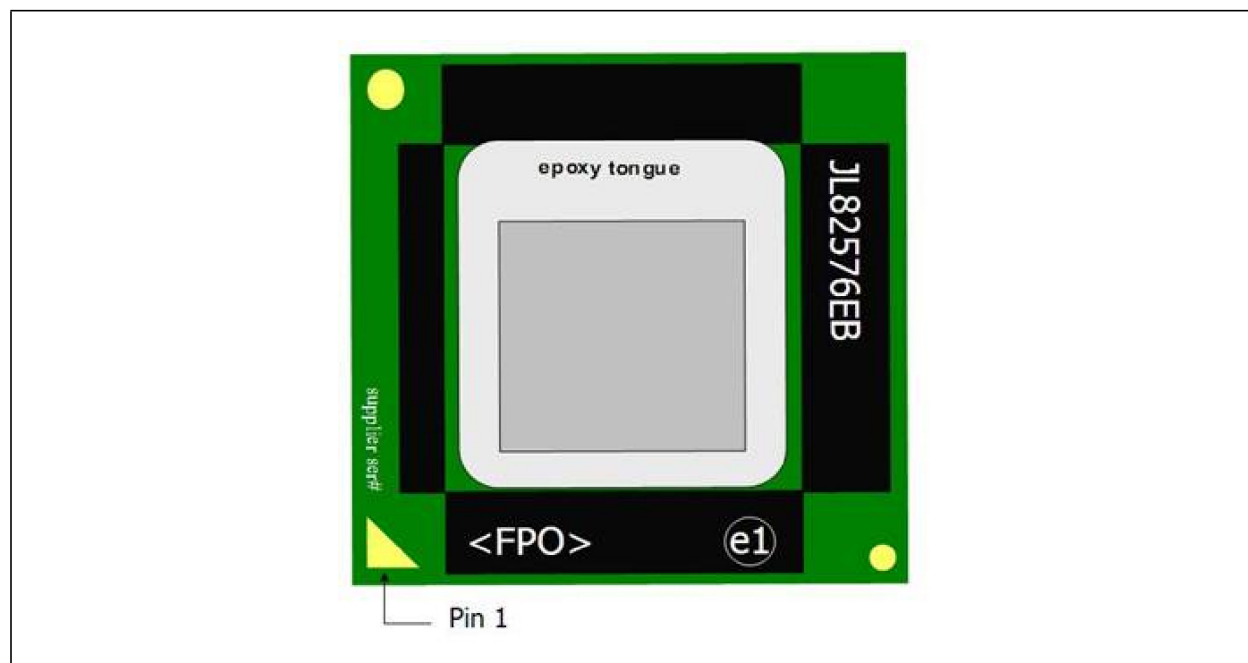
Figure 1. Example With Identifying Marks

There is an internal designator visible as a dash on the die side of some packages. It’s location may differ. The mark (looks like a dash, approximately 300X1000 µm in size) does not impact function.
