Intel® I/O Controller Hub 7 (Intel® ICH 7) Family

Specification Update

September 2013

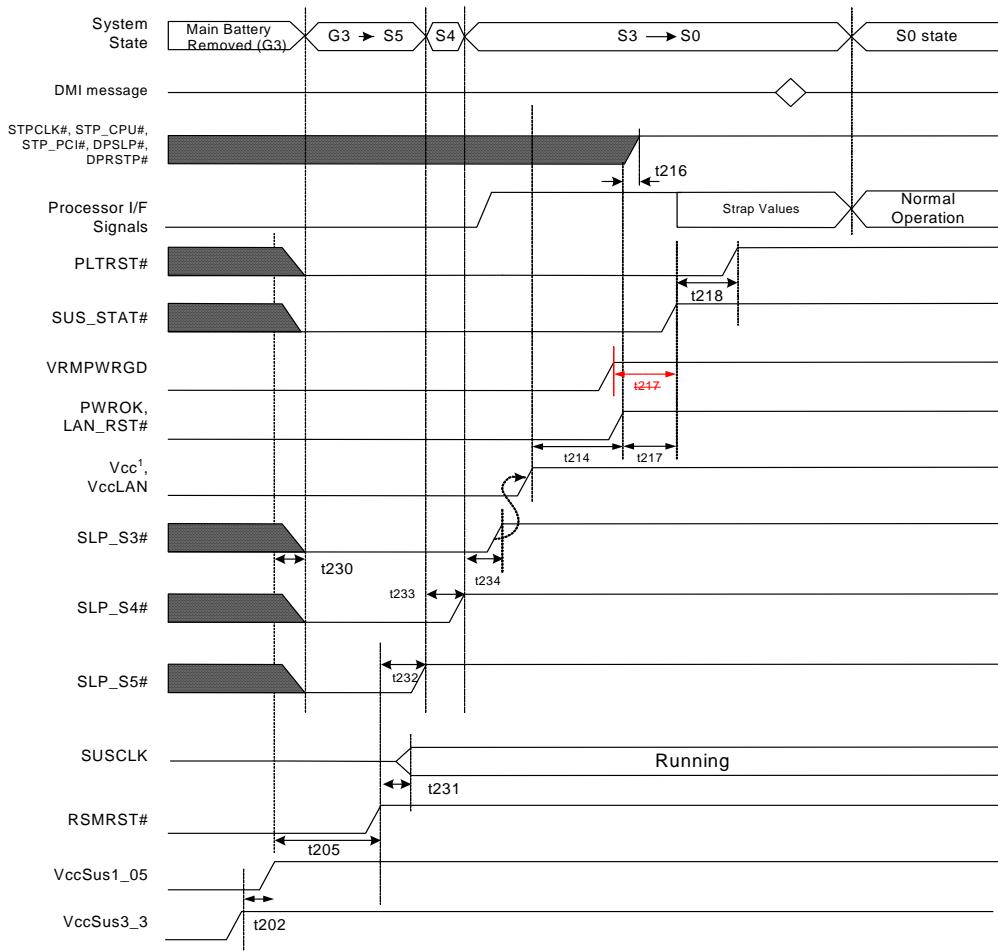
Remove t217 timing that points from VRMPWRGD going high to SUS_STAT# going high from Figure 23-21: G3 (Mechanical Off) to S0 Timings (Mobile/Ultra Mobile Only) in the Datasheet.

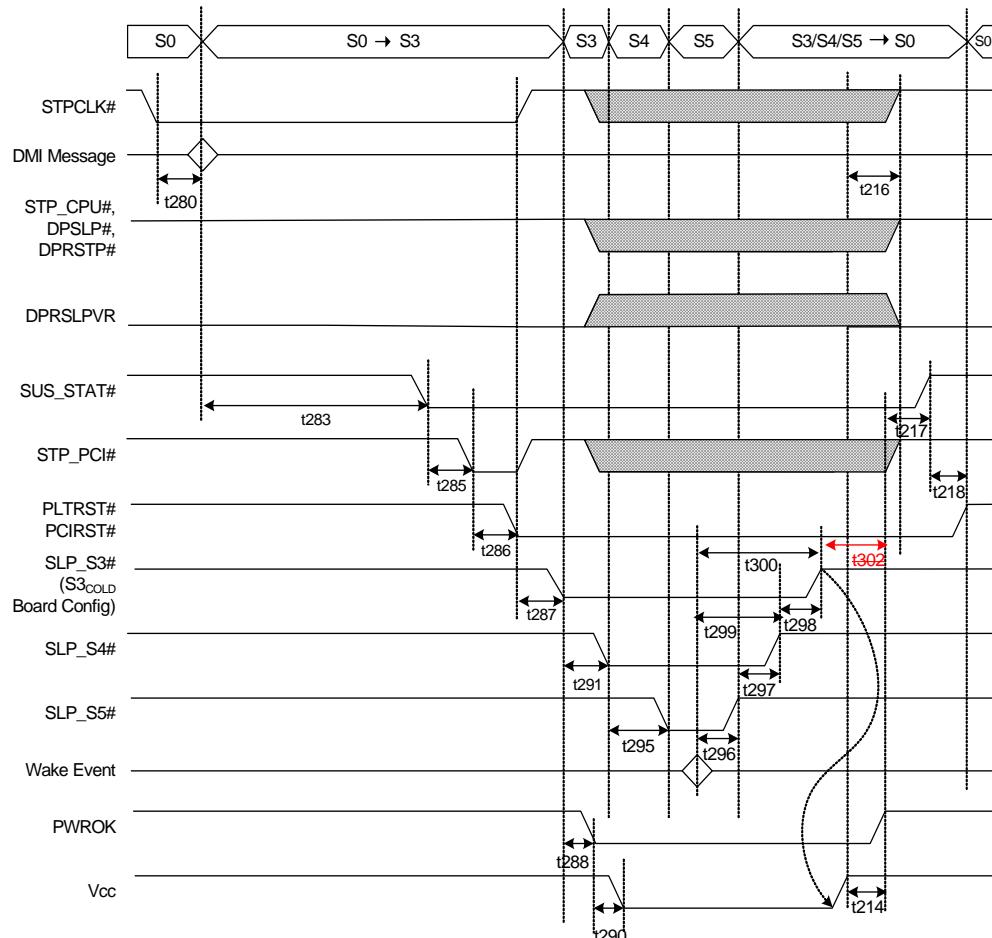
Figure 23-25 S0 to S5 to S0 Timings, S3_cold (Mobile/Ultra Mobile Only)

Remove the t302 timing requirement from Figure 23-25 S0 to S5 to S0 Timing, S3_cold (Mobile/Ultra Mobile Only) in the Datasheet.
