Intel[®] 81348 I/O Processor

Specification Update

May 2012

Order Number: 315041-009US

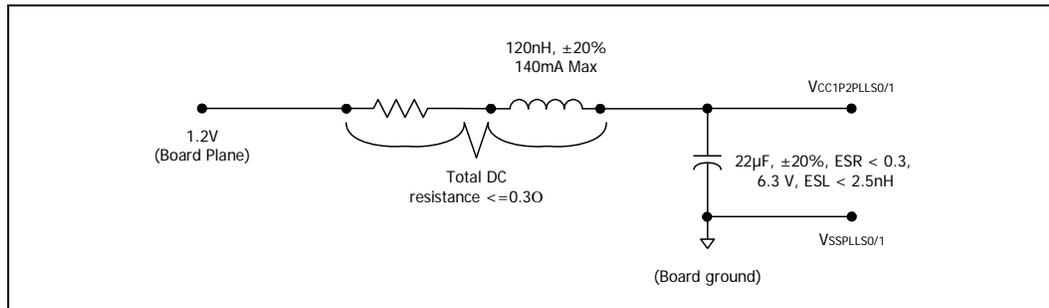
Figure 8. VCC1P2PLLS0, VCC1P2PLLS1 Low-Pass Filter

This paragraph pertains to the VCC1P2PLLS0, VCC1P2PLLS1 filters. The recommended filter for the PLL supplies is shown in Figure 8. The purpose of this filter is to achieve at least 10 dB rejection of frequencies between 1 and 20 MHz. The board supply distribution system must ensure that the minimum voltage into the PLL ball is equal to or greater than 1.164 V. The current draw for the IC is 95 mA typical less than 140 mA maximum. The filter components are selected to achieve a corner frequency of 100 KHz. The series resistance keeps the Q of this resonant circuit safely below unity for all component variations. The total DC resistance of the resistor and the inductor must be equal to or less than 0.3 Ohms.
