# Intel<sup>®</sup> 81341 and 81342 I/O Processors

Specification Update

*November 2008*

Order Number: 315042-008US

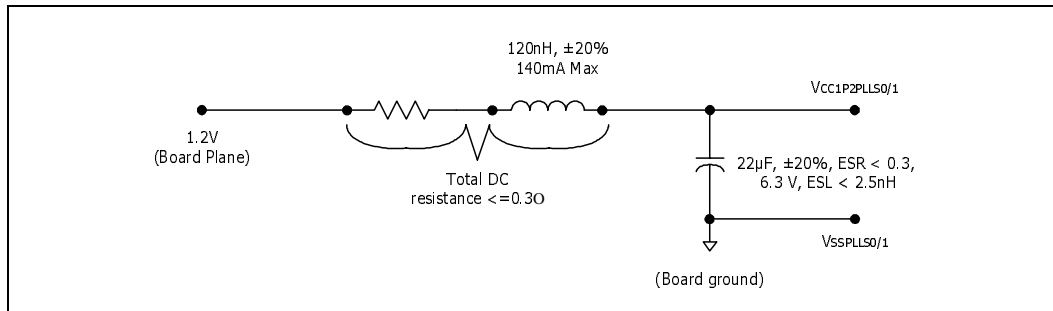
**Figure 8. VCC1P2PLLS0, VCC1P2PLLS1 Low-Pass Filter**

This paragraph pertains to the VCC1P2PLLS0, VCC1P2PLLS1 filters. The recommended filter for the PLL supplies is shown in Figure 8. The purpose of this filter is to achieve at least 10 dB rejection of frequencies between 1 and 20 MHz. The board supply distribution system must ensure that the minimum voltage into the PLL ball is equal to or greater than 1.164 V. The current draw for the IC is 95 mA typical less than 140 mA maximum. The filter components are selected to achieve a corner frequency of 100 KHz. The series resistance keeps the Q of this resonant circuit safely below unity for all component variations. The total DC resistance of the resistor and the inductor must be equal to or less than 0.3 Ohms.
