Intel[®] 81341 and 81342 I/O Processors

Specification Update

September 2008

Order Number: 315042-007US

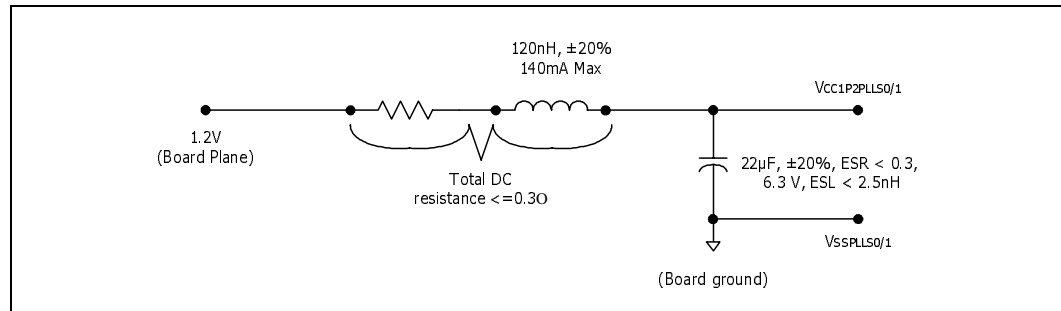
Figure 8. VCC1P2PLLS0, VCC1P2PLLS1 Low-Pass Filter

This paragraph pertains to the VCC1P2PLLS0, VCC1P2PLLS1 filters. The recommended filter for the PLL supplies is shown in Figure 8. The purpose of this filter is to achieve at least 10 dB rejection of frequencies between 1 and 20 MHz. The board supply distribution system must ensure that the minimum voltage into the PLL ball is equal to or greater than 1.164 V. The current draw for the IC is 95 mA typical less than 140 mA maximum. The filter components are selected to achieve a corner frequency of 100 KHz. The series resistance keeps the Q of this resonant circuit safely below unity for all component variations. The total DC resistance of the resistor and the inductor must be equal to or less than 0.3 Ohms.
