Intel[®] 413808 and 413812 SAS/SATA I/O Controllers

Specification Update

| *July 2008*

| Order Number: 315043-007US

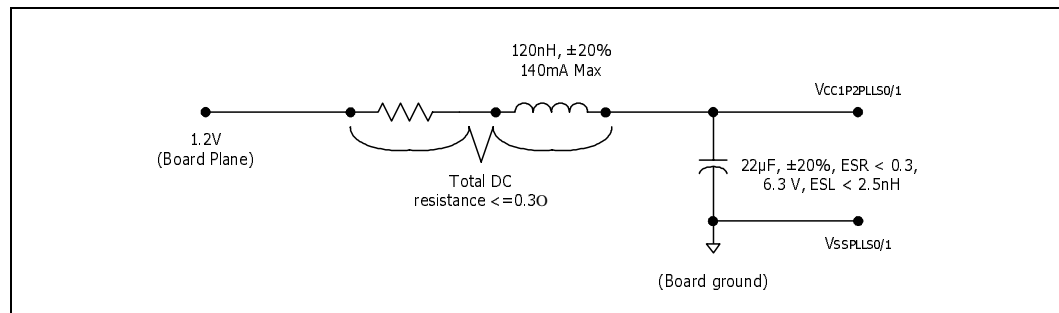
Figure 8. VCC1P2PLLS0, VCC1P2PLLS1 Low-Pass Filter

This paragraph pertains to the VCC1P2PLLS0, VCC1P2PLLS1 filters. The recommended filter for the PLL supplies is shown in Figure 8. The purpose of this filter is to achieve at least 10 dB rejection of frequencies between 1 and 20 MHz. The board supply distribution system must ensure that the minimum voltage into the PLL ball is equal to or greater than 1.164 V. The current draw for the IC is 95 mA typical less than 140 mA maximum. The filter components are selected to achieve a corner frequency of 100 KHz. The series resistance keeps the Q of this resonant circuit safely below unity for all component variations. The total DC resistance of the resistor and the inductor must be equal to or less than 0.3 Ohms.
