# Intel<sup>®</sup> 815 Chipset Family: 82815EP and 82815P Memory Controller Hub (MCH)

Specification Update

*June 2001*

Document Number: 290695-003

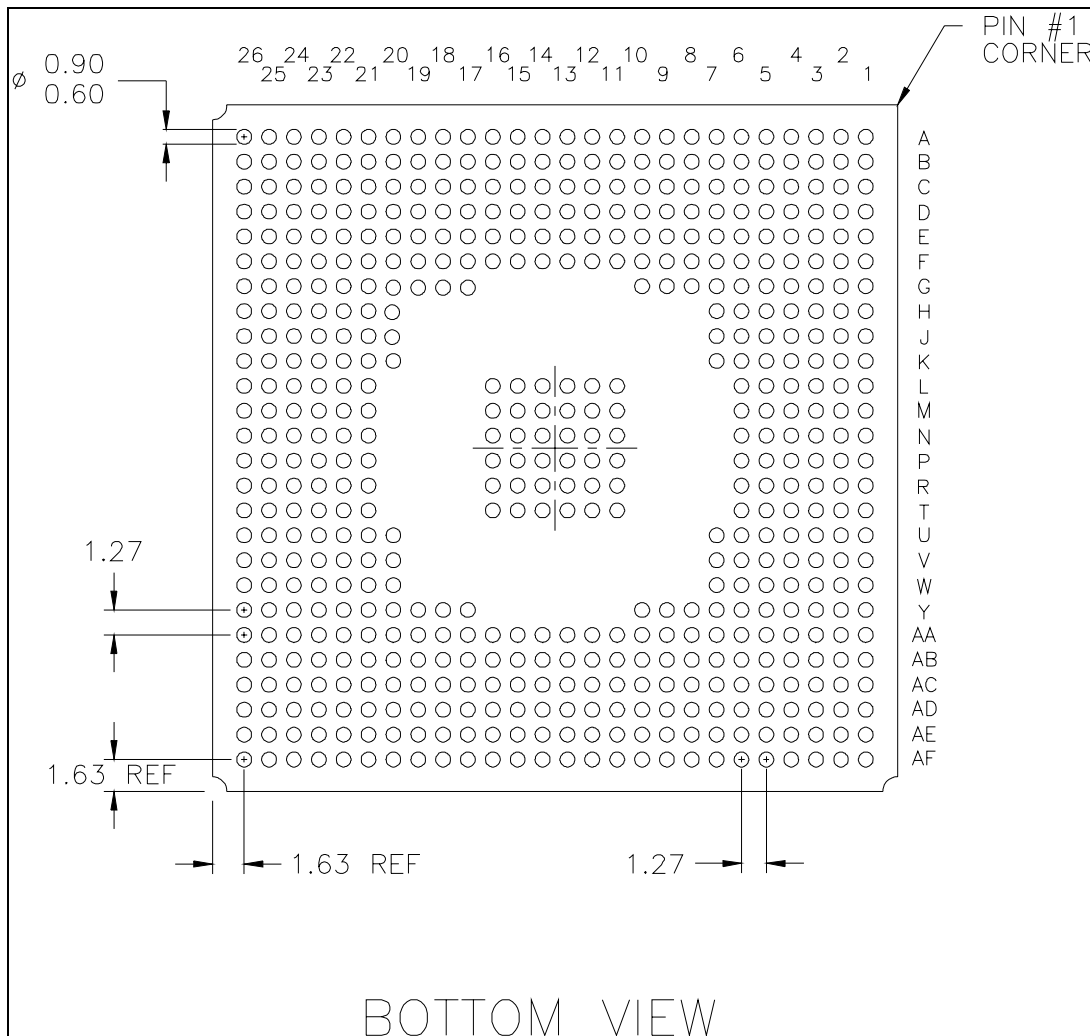
## 1. 82815EP 544 BGA Ball-Out Package is Corrected

Reference Section 5.2, *Package Information*. Replace Figure 13 with the following correct 544 BGA ball-out package bottom view:
