Intel® 41210 Serial to Parallel PCI Bridge Initialization by the SM Bus Using The PIC16F876A Microcontroller

White Paper

May 2004

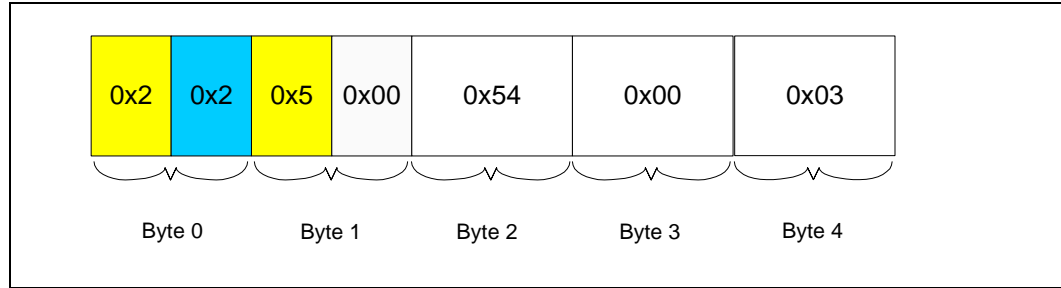
Figure 2. Errata 19 Customer Reference Code

Errata Description: The PCIExpress link is unreliable if the Intel® 41210 Serial to Parallel PCI Bridge enters L0s state

When L0s is enabled, the system may hang or behave in an unstable manner.

The workaround for this is to insure that entry into the L0s state is prevented using control bits in the EXP_LCTL control register Bits 0 and 1 of the PCI Express link control register at Configuration offset 54h must be set to 00b to disable L0s entry.

1. Write 0x00 to 1st Byte EXP_LCTL - PCI Express Link Control Register (0x54).

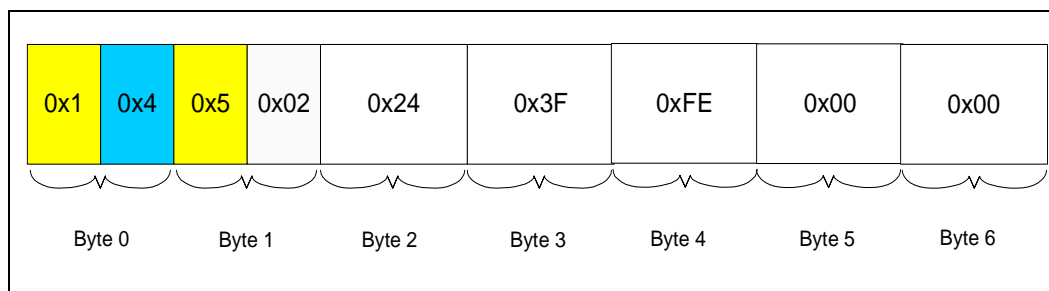
Figure 4. Errata 20 Implementation by the Customer Reference Code

Errata Description: Slow edge rates are observed when the Intel® 41210 Serial to Parallel PCI Bridge is driving the PCI-X bus at specific temperatures

The internal circuit used to set PCI/PCIX drive levels at power up does not always function correctly, possibly causing indeterminate drive levels on the PCI/PCI-X bus. This can be prevented by setting Bits 29:17 of the Configuration register at offset 224 to 1 for both PCI functions (0 and 2).

The workaround for this is to set bits of the compensation register, 0x224, starting at offset 0x226 of both PCI functions with 03FE h

1. Read 2 bytes from Offset 0x224, Compensation Register, into a variable that is 2 bytes long.
2. Set bits 29:17 on in the variable, 0x3FFE.
3. Write 2 bytes stored in the variable back to 0x224.

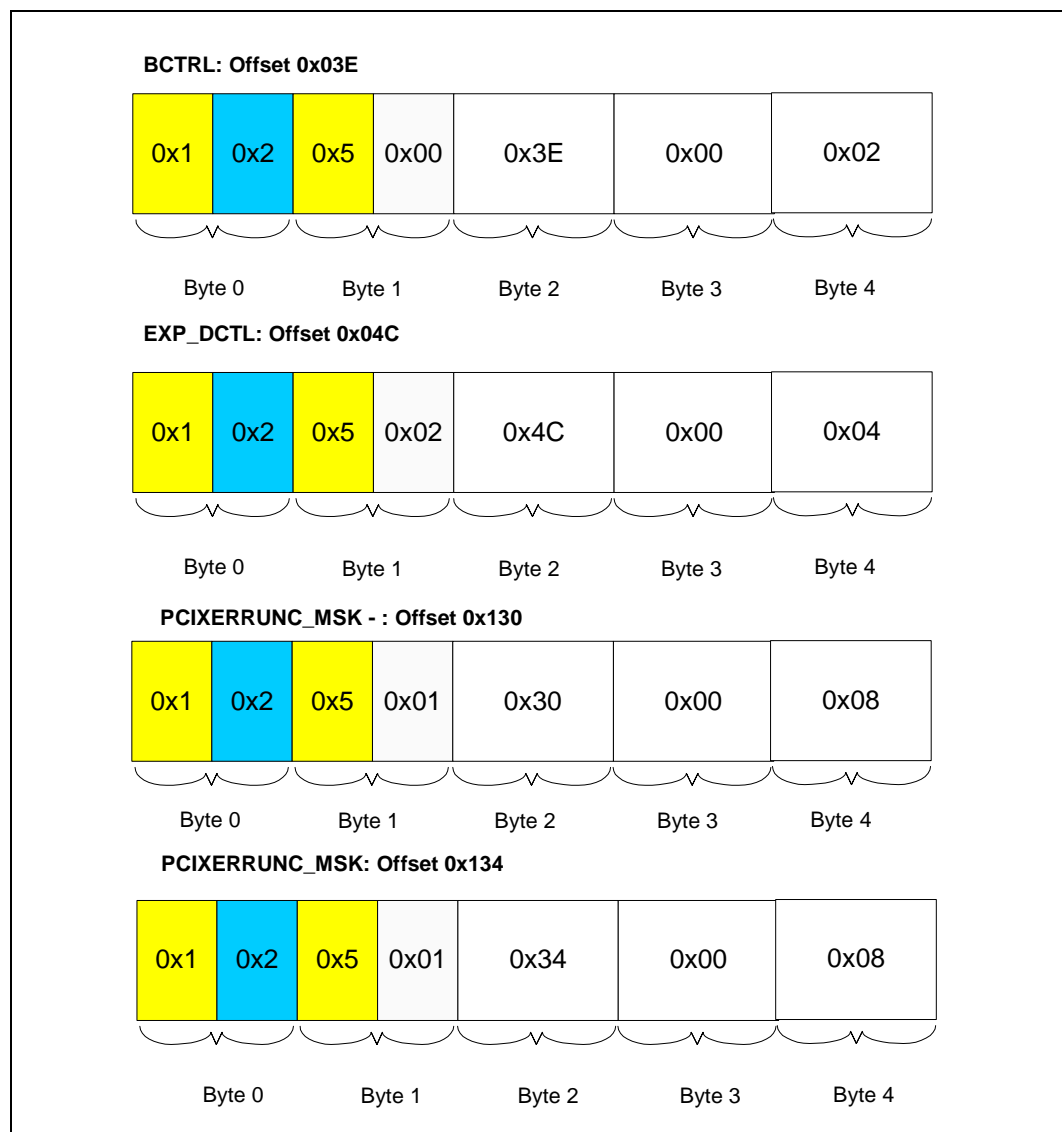
Figure 6. Errata 25 Implementation by the Customer Reference Code

Errata Description: PCI Parity error without ep field being set

In PCI and PCI-X mode using 32-bit data transfers, when a read request gets disconnected at an even dword boundary with data parity error, such that the subsequent request (for partial data) gets retried, the completion for this request is issued over PCI-Express to MCH (root complex) without the poisoned data 'ep' field set in PCI-Express TLP header. This could result in silent data corruption if escalation of uncorrectable errors is not enabled by BIOS.

To prevent such a parity error from going undetected, the following bits must be set in the 41210 device, and error escalation must be properly set in the PCIE root complex.
