# 21555 Non-Transparent PCI-to-PCI Bridge

Specification Update

*December 2002*

Order Number: [278337-008](#)

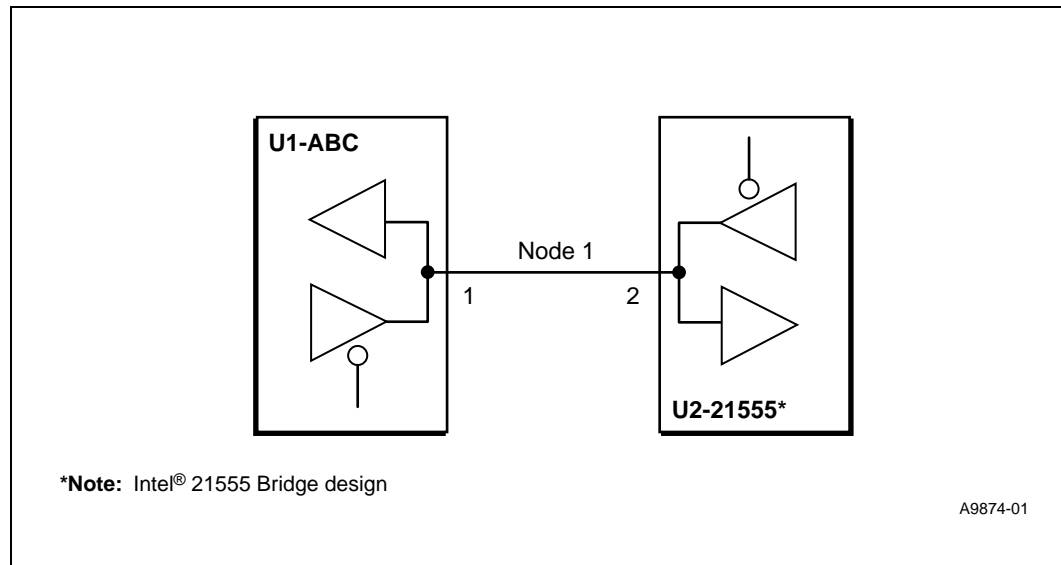
Figure 1. Node Boundary

### 1. **21555AA/BA boundary Scan Implementation is not compliant with IEEE 1149.1**

**Problem:** There is a one cycle delay before valid BSDL data is pushed out to the pins. The problem is due to an incorrect inversion in the equation that generates the JTAG update.

**Implication:** The parallel output data from any bi-directional pins, purely output pins or control cells, will be driven out exactly one clock after the UPDATE state. This is in violation of the IEEE1149.1 Specification.

To understand the potential issue in detail, refer to the diagram below. Node 1 is a bi-directional node, with U1.1 and U2.2 connected as shown. Assuming that U1 is an IEEE1149.1 compliant device, that U2 is the 21555, and that the control cells of the 21555 were set during the vectors to enable the driver of U2.2 to drive to U1.1 (receiver). When switching drivers from U2 to U1, U2 should tri-state its driver prior to, or at the same time as, U1 enables its driver. Since the 21555 UPDATES its Parallel Outputs one clock late and the control cells which enable U2's drivers are Parallel Outputs which again updates one clock cycle late then U2.2, which will be driving at the same time U1.1 is driving. This contention will happen for one TCK cycle, until U2 UPDATES its parallel outputs. The period of this contention is dependent on the TCK frequency rate.

A remedy to the 21555's late UPDATE is to ensure the chained Boundary Scan tester's vectors do not switch bus driver directions in one vector. This means that one vector should disable U2's driver, and the next vector should enable U1's driver. ATPG vectors typically are not manually manageable in this way and this requirement may force an engineer's manual intervention. No single stepping of test clock through the TAP State Machine should be allowed with the 21555 in the boundary scan chain. The resulting contention would increase the potential back drive time, increasing the possibility of device damage.

**Status:** Fixed. This behavior has been corrected in the 21555AB/BB Step A3 device.

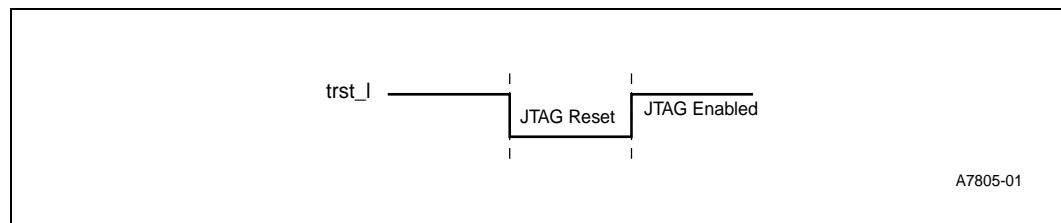
**Figure 12-1. Signal trst\_I States**

The test access port controller and the instruction register output latches are initialized and JTAG is disabled while the **trst\_I** input is asserted low (see Figure 12-1). While signal **trst\_I** is low, the test access port controller enters the test-logic reset state. This results in the instruction register being reset which holds the bypass register instruction. During test-logic reset state, all JTAG test logic is disabled, and the device performs normal functions. The test access port controller leaves this state only after **trst\_I** (low) goes high and an appropriate JTAG test operation sequence is sent on the **tms** and **tck** pins.

For the 21555 to operate properly, the JTAG logic must be reset. The controller resets:

- Asynchronously with the assertion of **trst\_I**.
- Synchronously after five **tck** clock cycles, with **tms** held high.

**Note:** Prior to normal 21555 operation, this signal must be strobed low or pulled low with a 1kΩ resistor.
