Intel[®] I/O Controller Hub 7 (ICH7) Family

Intel[®] ICH7 Family Specification Update

May 2012

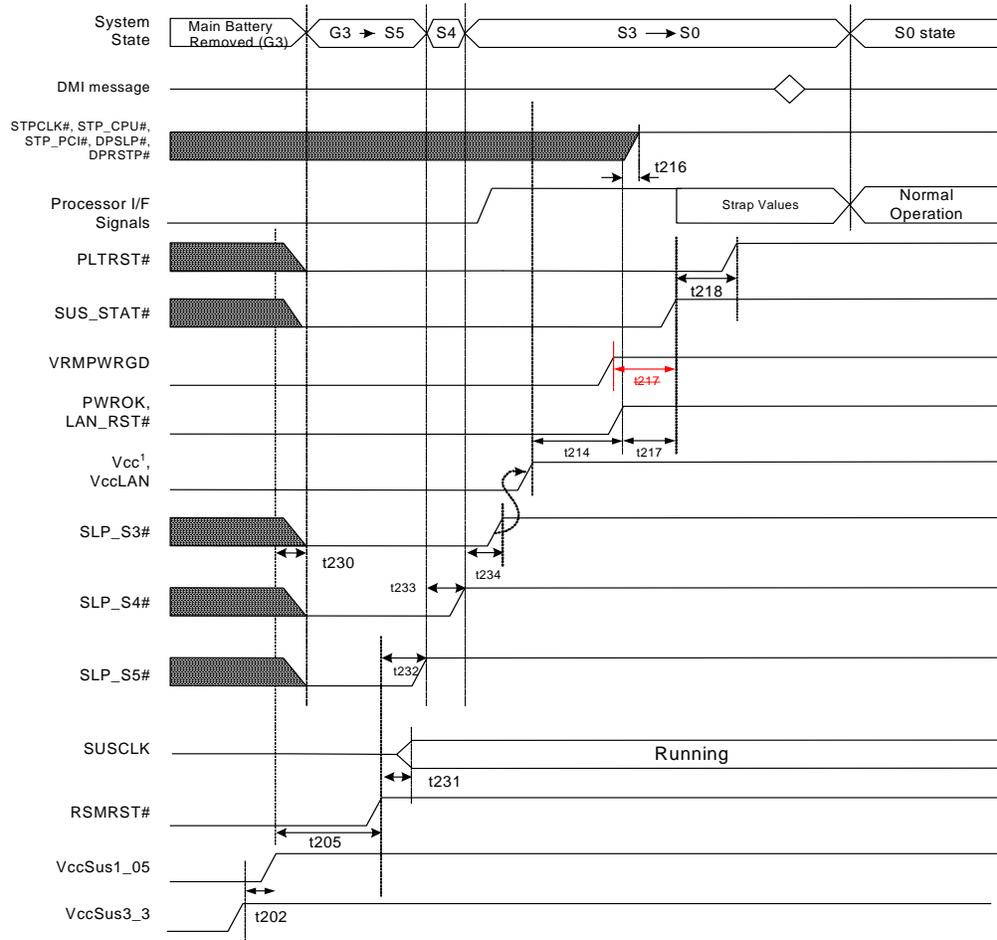
Remove t217 timing that points from VRMPWRGD going high to SUS_STAT# going high from Figure 23-21: G3 (Mechanical Off) to S0 Timings (Mobile/Ultra Mobile Only) in the Datasheet.
