Intel[®] Xeon[®] Processor 7100 Series

Specification Update

| *March 2010*

Order Number: 314554-006

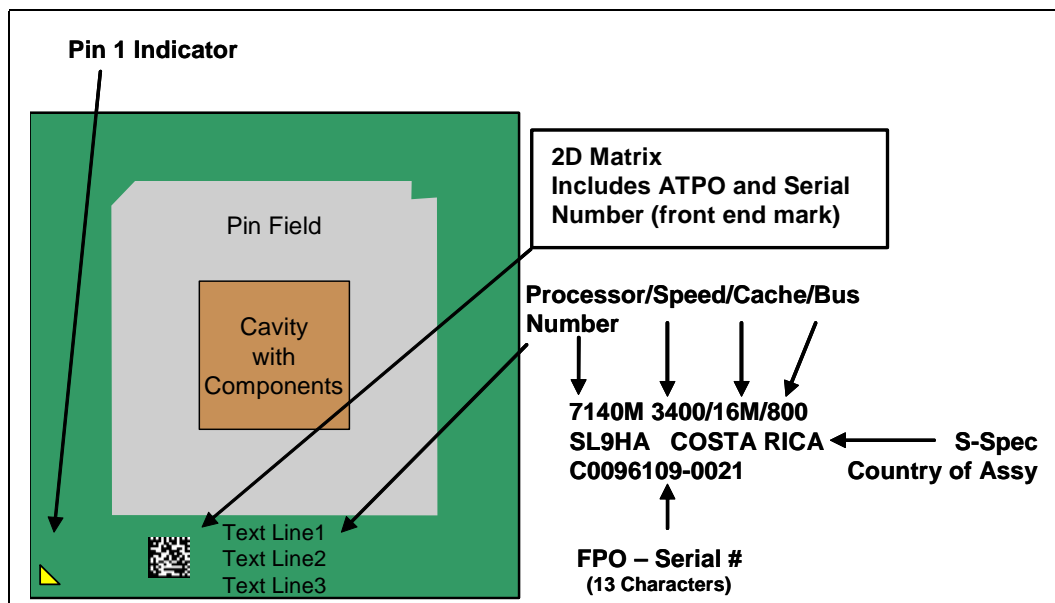
Figure 4-5. Processor Bottom-Side Markings has been updated to include a 2D Matrix.
