Mobile Intel® 965 Express Chipset Family Graphics Memory Controller Hub (G)MCH

Specification Update

May 2012

Revision 009

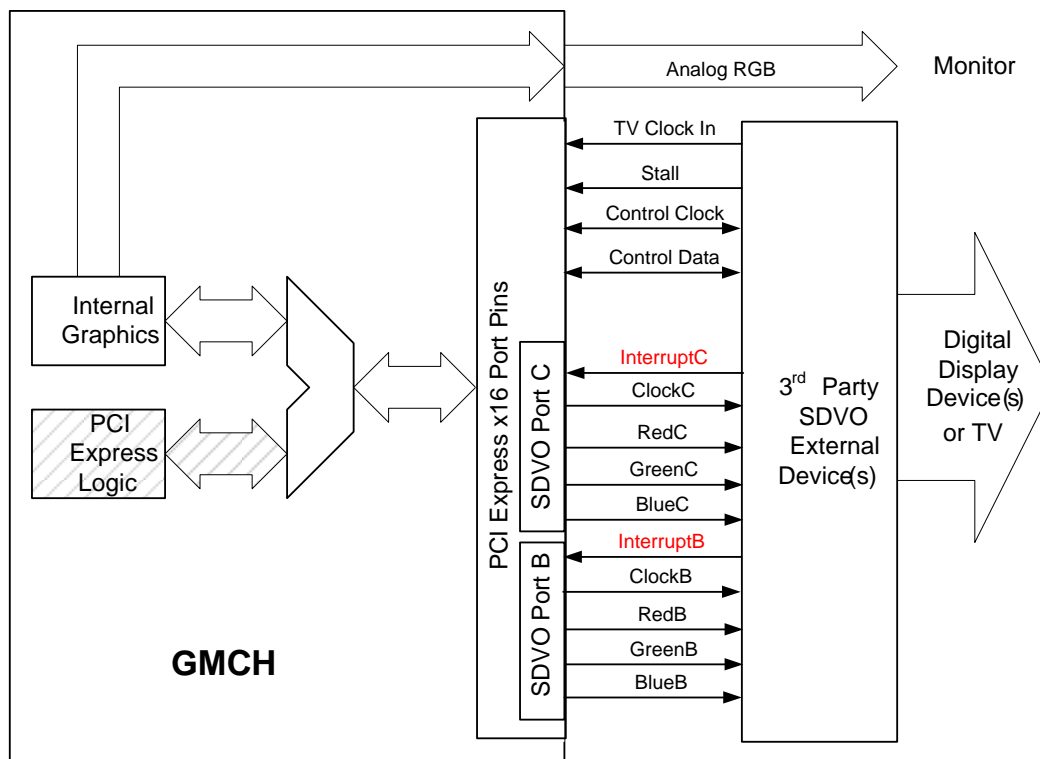
Section 6.3.1 Figure 10 SDVO Conceptual Block Diagram

2. SDVOB_INT and SDVOC_INT Signal Naming

Changes are in RED font.
