Intel[®] 5100 Memory Controller Hub Chipset

Specification Update

April 2010

Revision 010US

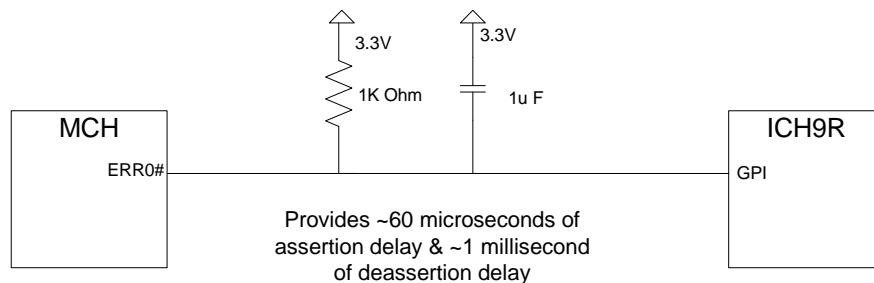
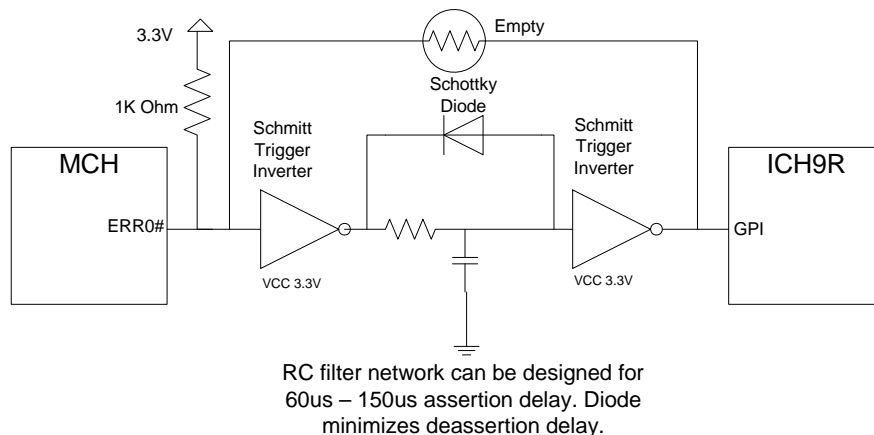
Problem: Any condition routed to MCH ERR[2:0]# output pins for SMI# escalation that would result in data poisoning on FSB will result in a CPU IERR# assertion due to race condition. The race condition exists between poisoned data presented to the FSB by the MCH and the uncorrectable error escalated to SMI# via ERR[2:0]# pins. If the CPU observes an SMI# assertion before the poisoned data is presented to the FSB, the CPU asserts MCERR# followed by IERR#. The CPU expects the SMI# assertion to occur at least ten BCLKs after the associated MCERR# assertion. Conditions that result in data poisoning on the FSB are uncorrectable memory ECC errors or poisoned TLPs received from any PCI Express* port.

Implication: CPU may assert IERR# and cause a system hang before the error may be logged in SMM.

Workaround: Any one of the three workarounds that have been identified may be selected.

1. Log errors upon reboot
 - System components (MCH, CPU, ICH9R) preserve errors across warm resets via sticky error registers
 - Requires a mechanism to reset system upon IERR# (server management controller, depress system reset button, and so forth)
2. Delay SMI# assertion by inserting a 60–150 µs delay on the ERR0# pin
 - Two recommended circuit solutions (other solutions may be possible):

- Route errors that result in FSB data poisoning to the ERR0# pin (IO4, M1)
- 3. Disable FSB data parity checking on CPU
 - Prevents CPU from asserting MCERR# on poisoned data
