# Monthly Specification Update

***Intel® Server Board S3420GP***

*Intel Order Number E82362-009*

**December 2011**

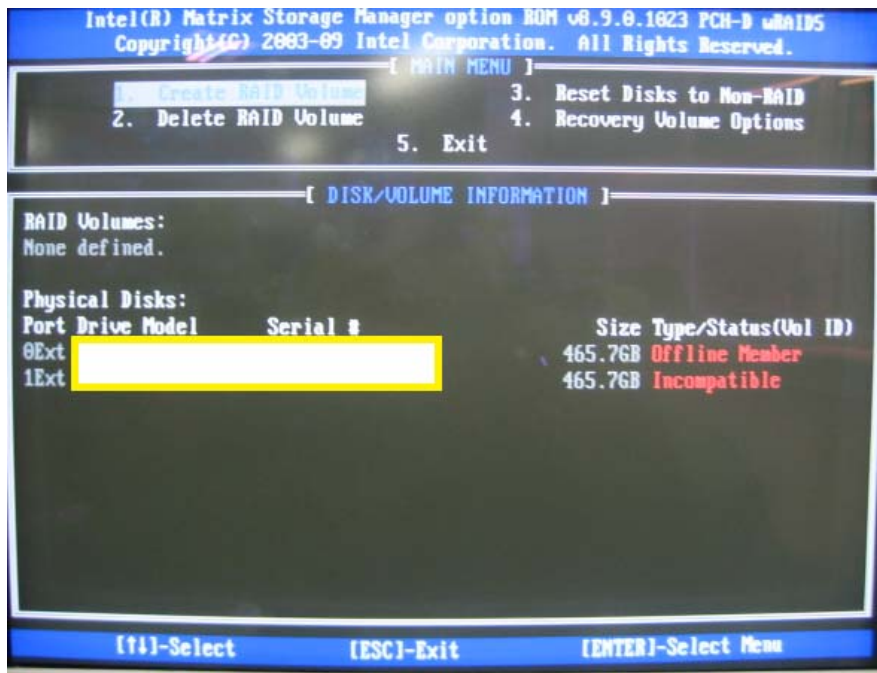
Figure 1. HDD Incompatible Status

Problem	Under RAID 1 mode, if the operating system does reboot after one HDD is unplugged, the other HDD will show incompatible status even after the other HDD is plugged in again.
Implication	Please refer to the picture below.

Status	This issue was fixed in BIOS version 0048.
Workaround	Downgrade BIOS to version 0042 when the issue is happening.
