# Monthly Specification Update

***Intel® Server Boards S5000PSL and S5000XSL***

*Intel Order Number D62900-001*

**February, 2011**

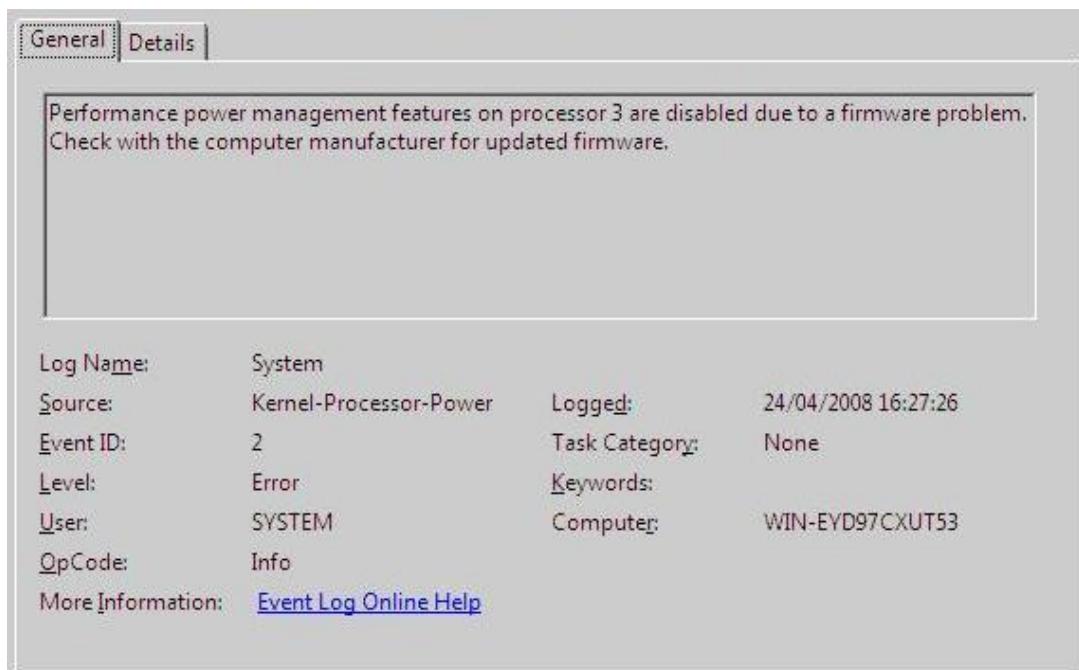
**Problem** Microsoft Windows Server 2008\* and/or Microsoft Windows Vista\* in Intel® Server Board S5000PSL and/or Intel® Workstation Board may have a Performance Power Management error in the Microsoft Windows System Event Log\* like the following illustration:

**Implication** Current version of the BIOS displays a default dummy PSS object (P-State info) in ACPI space for processors that do not support Enhanced Intel® SpeedStep® Technology to indicate no P-State supported; however, this is interpreted as a Performance Power Management error in the Operating System log. This is a harmless message and does not impact system performance or functionality.

**Status** This erratum is fixed by BIOS91.6
