Monthly Specification Update

Intel® Server Board S2600WP Family
Intel® Server System H2000WP Family

Intel Order Number G64830-012

January, 2015

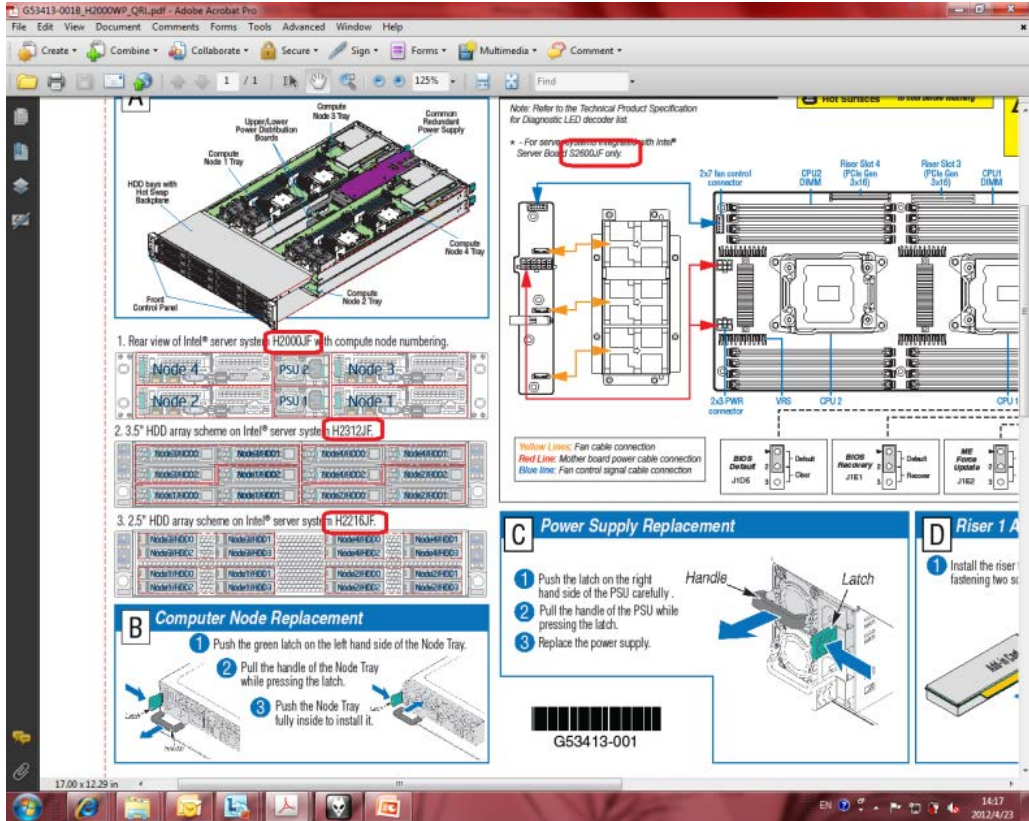
Figure 1. The Chassis Quick Reference with Incorrect Picture Titles

Problem The *Intel® Server System H2000WP Family Chassis Quick Reference* (document ID G53413-001) has four incorrect picture titles as shown below. The correct title names should be "H2000WP", "H2312WP", "H2216WP", and "S2600WP". All schemes and configuration diagrams are correct for H2000WP. The impacted servers systems are listed in the table below. This problem has been fixed in the updated Chassis Quick Reference (document ID G53413-002).

Implication The picture titles do not match the pictures.
