Intel Technical Advisory

TA-1011-01

I²C CABLE CONNECTION ISSUE WITH INTEL[®] SERVER SYSTEM P4208CP4MHGC

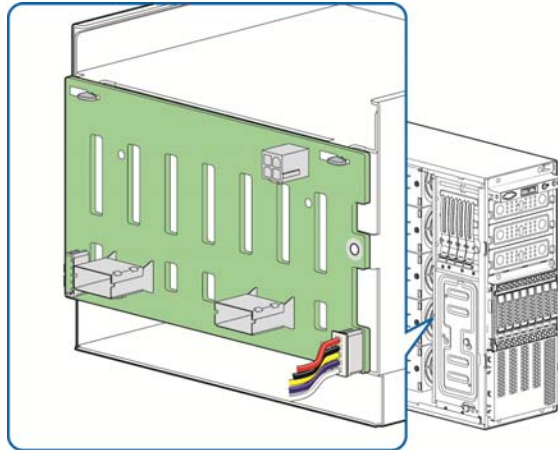
In the Intel[®] Server System P4208CP4MHGC with the above mentioned Serial Numbers, the I²C cable is connected to the connector labeled "I2C_OUT" on the backplane (Figure 1). However, to install a second backplane in the system, the I²C cable needs to be connected to the connector labeled "I2C_IN" on the original installed backplane (Figure 2).

Figure 1. I²C cable is connected to the "I2C_OUT" connector

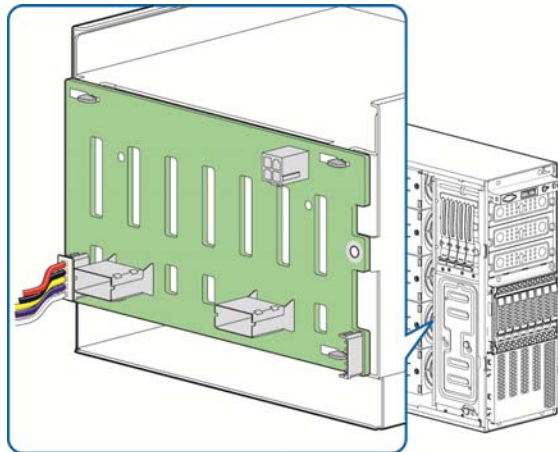
Figure 2. I²C cable is connected to the "I2C_IN" connector

Intel is implementing a change in manufacturing to connect the I²C cable to the "I2C_IN" connector on the original backplane in the Intel[®] Server System P4208CP4MHGC, as shown in Figure 2 above.

Customers should connect the I²C cable to the "I2C_IN" connector on the original backplane (Figure 2) in the Intel[®] Server System P4208CP4MHGC.

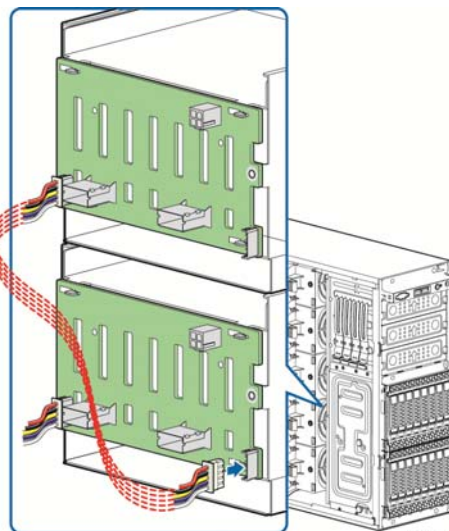
When installing a second backplane in the Intel[®] Server System P4208CP4MHGC, the two backplanes need to be cascaded with two I²C cables. The first I²C cable should connect to the "I2C_IN" connector on the first backplane, and the second I²C cable should connect from the "I2C_OUT" connector on the first backplane to the "I2C_IN" connector on the second backplane (Figure 3).

Figure 3. Cascaded I²C cable connection for two backplanes
