# Intel Technical Advisory

TA-1047-1

**Customers may experience system shutdown and then reboot in power supply redundancy mode when inserting or removing any one of the power supply units, or when system encounters unexpected power supply unit failure.**

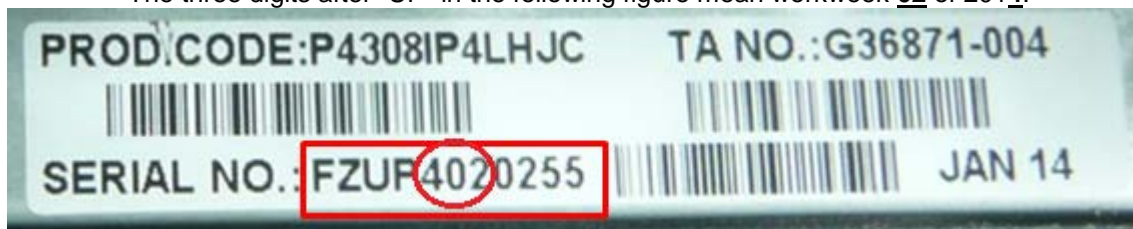
Intel has determined the Intel® Server System P4000IP4 and Workstation System P4000CR2 using power supply redundancy function with serial number before workweek 02 of 2014 may be affected by this issue. Customers can identify the workweek by referring to the following example.

The three digits after "UP" in the following figure mean workweek **02** of 2014.

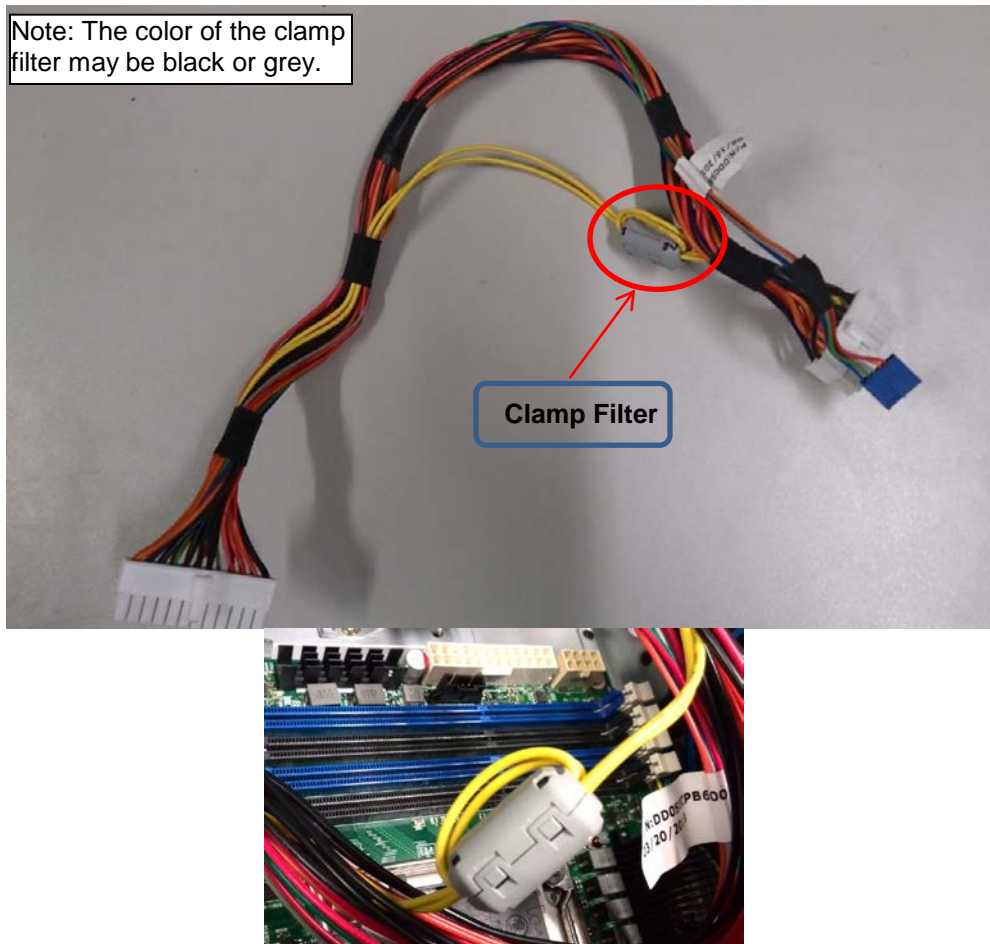
When inserting or removing of one power supply unit, or unexpected power down of any one of the power supply units occurs, the noise from P12V coupled to adjacent signal wires in the same cable bundle may cause the voltage of the remote sense signals to fluctuate beyond their voltage thresholds, and induce the failure of power supply redundancy mode, depending on cable assembly state.

Intel is implementing a clamp filter onto the P12V power wires to fix the issue. For the Intel® Server System P4000IP4 and Workstation System P4000CR2 that have the power supply redundancy function, Intel recommends customers replace the cable set with the clamp filter pre-installed cable.

**Please contact Intel using your normal warranty process, indicating that you are calling to replace the cable set regarding TA-1047-1. Having the following information when you call: the serial number(s) of the affected system(s) and the cable part number DD0S6CPB600.**
