Intel Technical Advisory

TA-1047-1

January 26, 2014

Customers may experience system shutdown and then reboot in power supply redundancy mode when inserting or removing any one of the power supply units, or when system encounters unexpected power supply unit failure.

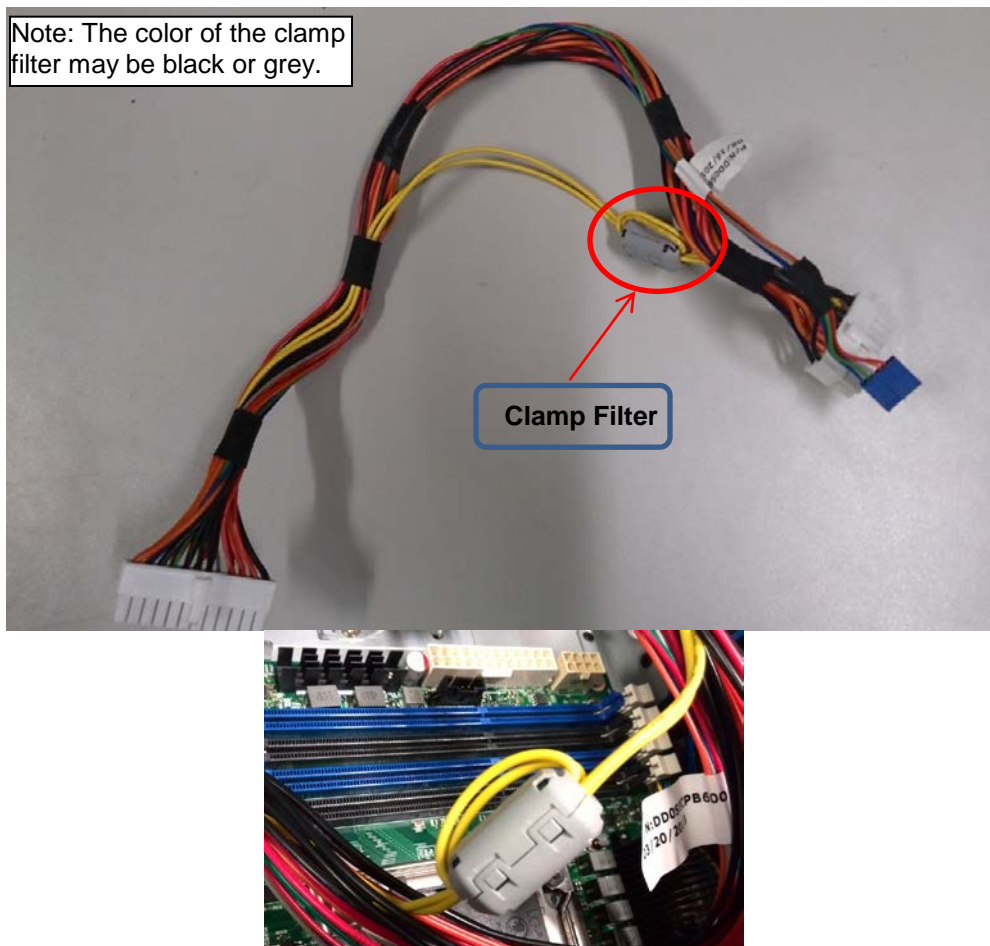
When inserting or removing of one power supply unit, or unexpected power down of any one of the power supply units occurs, the noise from P12V coupled to adjacent signal wires in the same cable bundle may cause the voltage of the remote sense signals to fluctuate beyond their voltage thresholds, and induce the failure of power supply redundancy mode, depending on cable assembly state.

Intel is implementing a clamp filter onto the P12V power wires to fix the issue. For the Intel® Server System P4000IP4 and Workstation System P4000CR2 that have the power supply redundancy function, Intel recommends customers replace the cable set with the clamp filter pre-installed cable.

Please contact Intel using your normal warranty process, indicating that you are calling to replace the cable set regarding TA-1047-1. Having the following information when you call: the serial number(s) of the affected system(s) and the cable part number DD0S6CPB600.
