Intel Technical Advisory

TA1056-01

Potential system shutdown on the Intel[®] Server System P4000IP Family and the Intel[®] Server Chassis P4000M Family during certain RAID operations

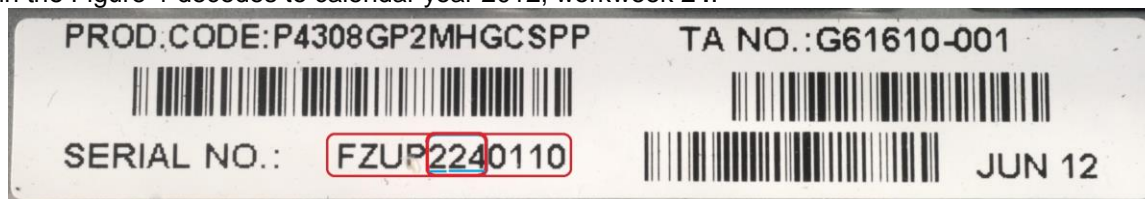
Figure-1: Workweek example

Customers can identify the workweek and calendar year by referring to the following example (Figure-1). The three digits after "UP" in the Figure-1 decodes to calendar year 2012, workweek 24.

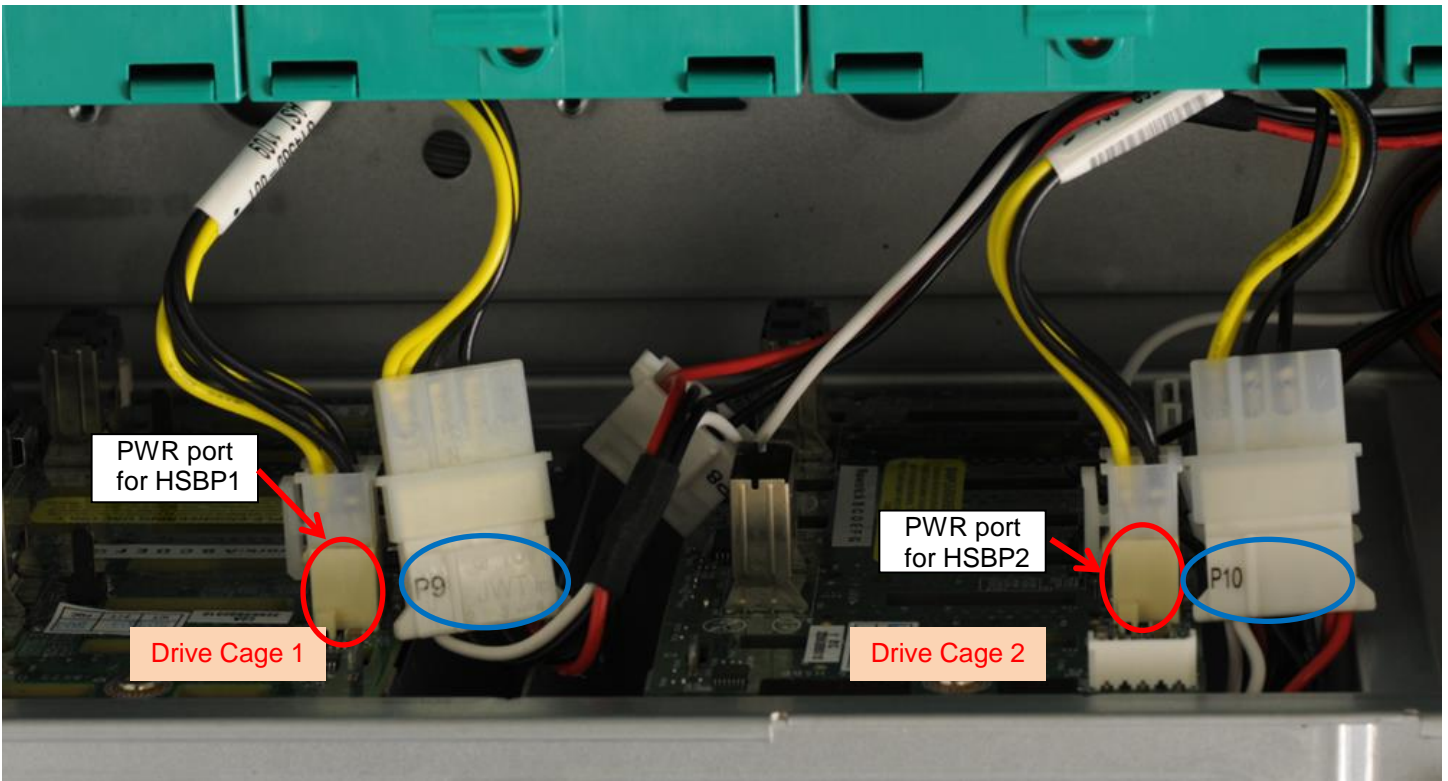
Figure-2: The Default Power Rail Connection

The affected products above may experience system shutdown during certain RAID operations when one power rail is connected to two 8x2.5" Hot Swap Drive Cage Kits. This issue occurs when the peak current on this power rail is larger than 18 amperes for longer than 0.6 milliseconds. Certain RAID operations such as full initiation and consistency check cause concurrent operation of all HDDs, which may generate current demands in excess of the 18 amperes / 0.6 millisecond limitation.

The power rail of the power distribution board (PDB) on the affected server systems has an Over Current Protection (OCP) circuit design that follows the standard 240VA regulation. This OCP circuitry will shut down the system when the peak current is larger than 18 amperes with the duration longer than 0.6 milliseconds. Intel has performed technical analysis and testing, and determined that the peak current is dependent on the HDD model, HDD quantity, and RAID configuration.

Scenario #	Scenario-1	Scenario-2	Scenario-3
Configuration	One additional Hot Swap Drive Cage Kit FUP8X25HSDKS is used to upgrade from 8x HDD configuration to 16x HDD configuration. The power connector P8/P9 (White) and P10/P11 (White) are connected to the HSBP-1 PWR port and HSPB-2 PWR port respectively (Figure-2).	The default configuration of two 8x 2.5" drive cages (16x HDD configuration). The power connector P8/P9 (White) and P10/P11 (White) are connected to the HSBP-1 PWR port and HSPB-2 PWR port respectively (see Figure-2).	One additional Hot Swap Drive Cage Kit FUP8X25HSDKO is used to upgrade from 16x HDD configuration to 24x HDD configuration.
Affected Products	FUP8X25HSDKS	P4216IP4LHJC P4216IP4LHKC P4216XXMHJC P4216XXMHGC P4216XXMHGR	FUP8X25HSDKO
Corrective Action	Reconnect the power connector P10 to the HSBP-1 PWR port and the power connector P7 to the HSPB-2 PWR port (Figure-3).		Intel will provide an updated PDB to customers starting from May 5 th , 2014. Please indicate you are calling regarding TA-1056-01, and have the following information when you call: serial number(s) for the system(s) needing the replacement part. You can refer to the related products service guide for how to replace the PDB. The Service Guide is available on http://www.intel.com/support/motherboards/server/sb/CS-033321.htm
