# Intel Technical Advisory

TA-1054-01

## Incorrectly wired SATA power cables on the Intel<sup>®</sup> Server System P4000 Family and the Intel<sup>®</sup> Server Chassis P4000 Family

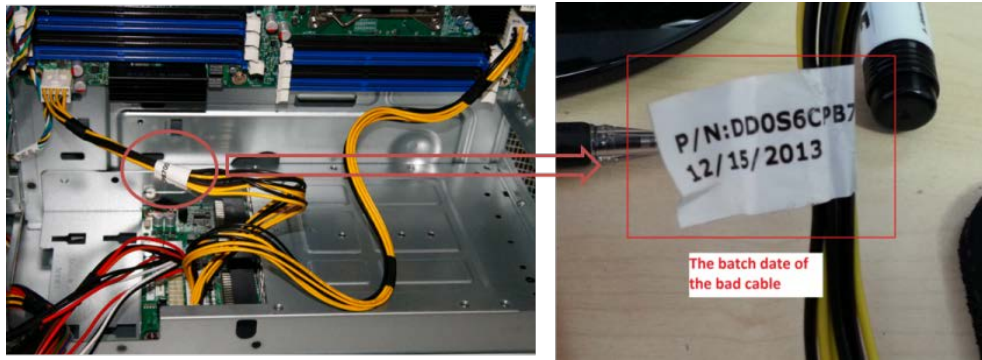
Figure 1. Location of the date code "P/N DD0S6CPB700 12/15/2013"

It has been confirmed that the issue happens only with a certain date code "P/N DD0S6CPB700 12/15/2013" of the power cable that connects to the 2x12 pin connector (labeled "Main PWR1") on the PDB. Customers can identify the date code by locating the label shown in Figure 1.

Intel will provide the correct power cable to customers as a replacement upon request. Please contact Intel using your normal warranty process to obtain the cable. Please indicate you are calling regarding TA-1054-01 for a replacement cable with the part number DD0S6CPB700 and have the following information when you call: serial number(s) for the system(s) or chassis.

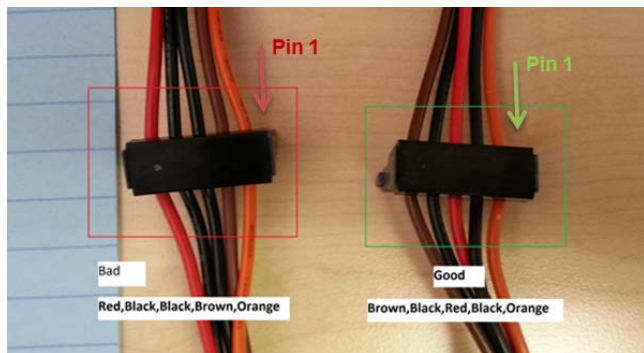
Figure 3. Pin connection of the two SATA 1x5 pin Peripheral Power Connectors (labeled P5 and P6)

Intel has determined that this failure is due to the incorrectly wired pin connection on the two SATA 1x5 pin Peripheral Power Connectors (labeled P5 and P6). The correct pin definition of the connector should be Orange, Black, Red, Black, and Brown from Pin 1 while the problematic connectors are wired in a different order as Orange, Brown, Black, Black, and Red from Pin 1.

Intel has screened the current inventory to ensure systems and chassis are shipped with the correct SATA power connectors.
