Intel Technical Advisory

TA-1054-01

April 4, 2014

Incorrectly wired SATA power cables on the Intel® Server System P4000 Family and the Intel® Server Chassis P4000 Family

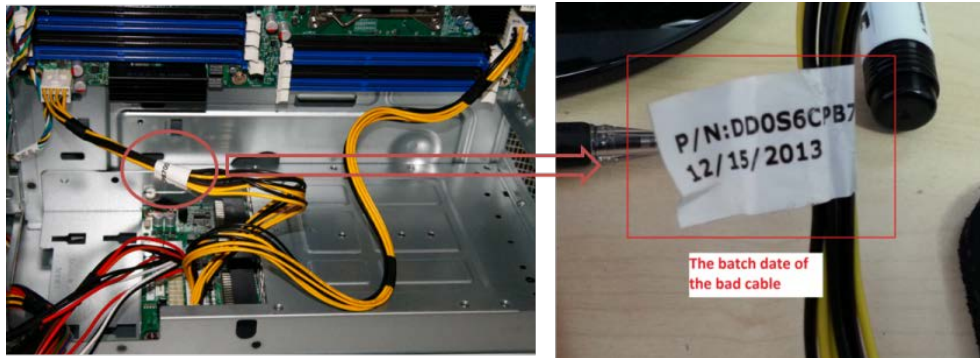
It has been confirmed that the issue happens only with a certain date code "P/N DD0S6CPB700 12/15/2013" of the power cable that connects to the 2x12 pin connector (labeled "Main PWR1") on the PDB. Customers can identify the date code by locating the label shown in Figure 1.

Figure 1. Location of the date code "P/N DD0S6CPB700 12/15/2013"

Intel will provide the correct power cable to customers as a replacement upon request. Please contact Intel using your normal warranty process to obtain the cable. Please indicate you are calling regarding TA-1054-01 for a replacement cable with the part number DD0S6CPB700 and have the following information when you call: serial number(s) for the system(s) or chassis.

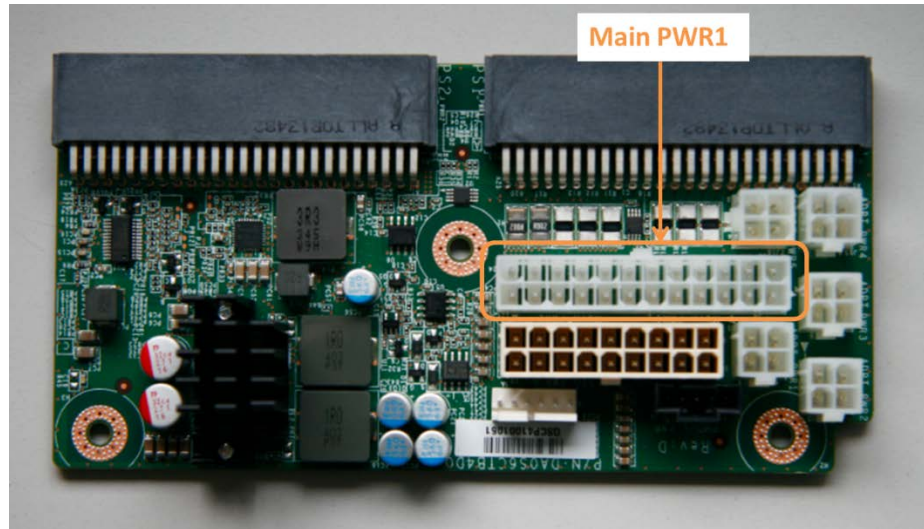
Figure 2. Location of the 2x12 pin connector (labeled "Main PWR1") on the PDB

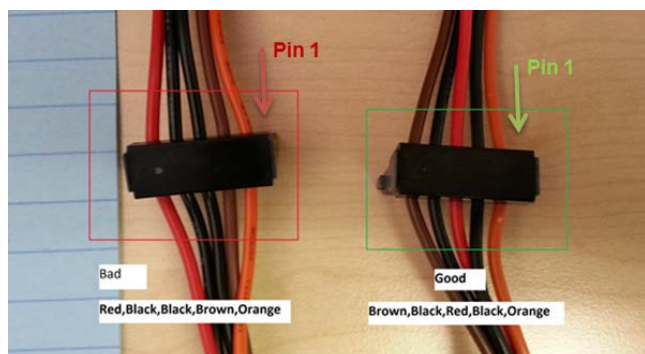
Intel has determined that this failure is due to the incorrectly wired pin connection on the two SATA 1x5 pin Peripheral Power Connectors (labeled P5 and P6). The correct pin definition of the connector should be Orange, Black, Red, Black, and Brown from Pin 1 while the problematic connectors are wired in a different order as Orange, Brown, Black, Black, and Red from Pin 1.

Figure 3. Pin connection of the two SATA 1x5 pin Peripheral Power Connectors (labeled P5 and P6)

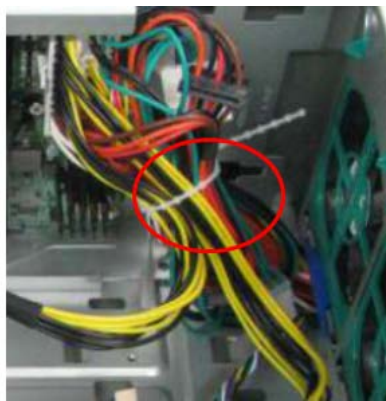
Figure 4. Location of the wire tie

1. Remove the side cover and the air duct from the system or chassis by referring to the Service Guide of your affected product. The Service Guide is available on http://www.intel.com/p/en_US/support.
2. Remove wire tie and put it in a safe place for reuse.

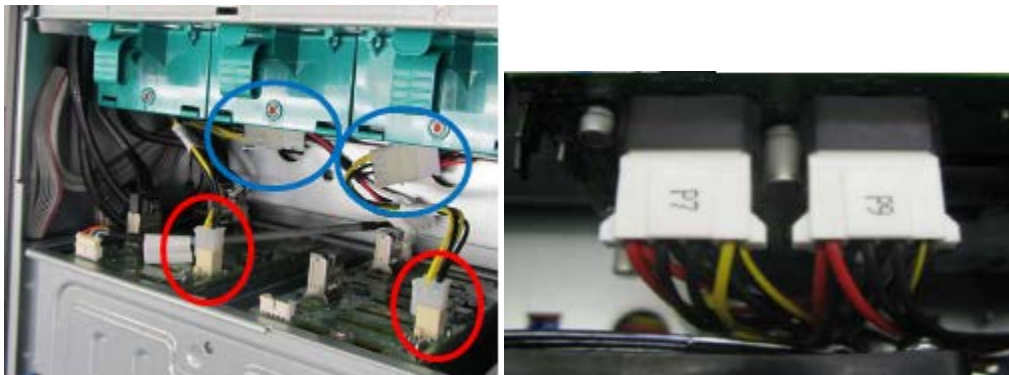
Figure 5. Location examples of the power connectors

3. Note down the original locations of the P2, P3, P5, P6, P7, P8, P9, P10, P11 power connectors if they are connected to the backplane board, motherboard, or peripheral devices, and then remove the connectors. See the following figures for some location examples of these power connectors.

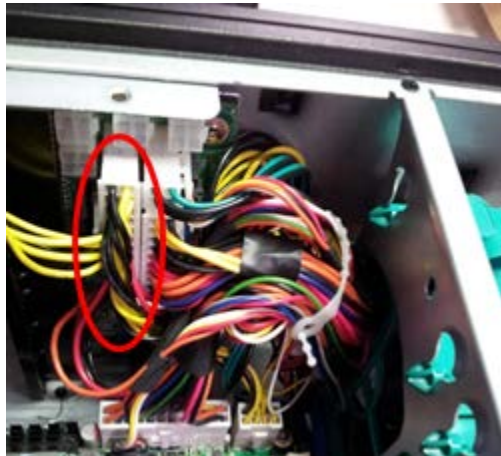
Figure 6. Location of the "Main PWR1" connector

4. Remove the 2x12 pin power cable from the "Main PWR1" connector of the PDB and replace it with the new cable that Intel ships to you.

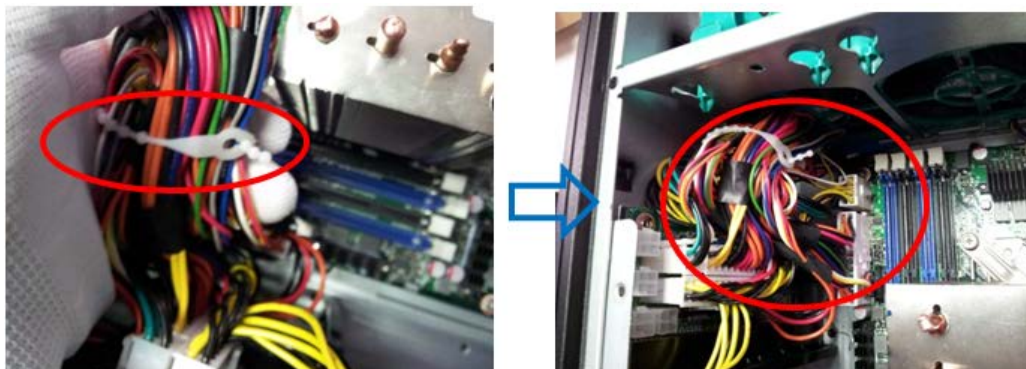
Figure 7. Location of the wire tie

5. Re-connect the P2, P3, P5, P6, P7, P8, P9, P10, P11 power connectors to the backplane board, motherboard, or peripheral devices based on the notes in step 3.
6. Fasten the wire tie.
