Mobile Intel[®] Celeron[®] Processor at 466 MHz, 433 MHz, 400 MHz, 366 MHz, 333 MHz, 300 MHz, and 266 MHz Specification Update

Release Date: December 2002

Order Number: 244444-039

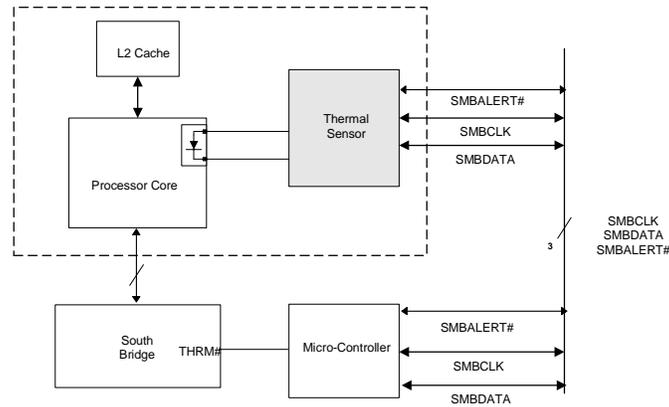
Figure 1. An Example of Microcontroller Driven Thermal Management

H29. Thermal Sensor May Assert SMBALERT# Incorrectly

Problem: The Intel Celeron Processor Mobile Module has a thermal sensor that monitors the processor core's temperature. Please note that desktop systems could have a similar thermal device. The thermal sensor asserts SMBALERT# if the processor temperature exceeds the temperature limits set in the Alarm Threshold Registers (T_{HIGH} , T_{LOW}). It also sets the corresponding Status Register bits to identify the cause of the interrupt. Figure 1 gives one example of the how the SMBALERT# signal could be used in a system.

Implication: There is no system impact from this erratum if temperature polling is used for processor thermal management. If the SMABLER# interrupt is employed to manage processor thermal sensing, then servicing the false interrupt may result in premature system action depending on the software and hardware implementations used. The rate of the false interrupts is less than the auto-convert rate of the thermal sensor.

1. Before servicing an interrupt from the thermal sensor, read and compare the processor thermal reading with the threshold limits (T_{HIGH} or T_{LOW}). Figures 2 and 3 provide basic flowcharts for the implementation of this workaround in an interrupt driven system.
2. If the firmware implemented polls the Status Register only, then before taking any action, re-read the temperature register and do a comparison with the alarm threshold limits (T_{HIGH} or T_{LOW}) to determine if the value is actually still within the temperature window.
3. Use a temperature polling scheme to monitor the processor temperature.
