## **Intel Technical Advisory**

TA-1165

# Incorrect Cabling on LWF2224NX Leads to Erroneous Display in Nutanix\* PRISM Hardware Diagram

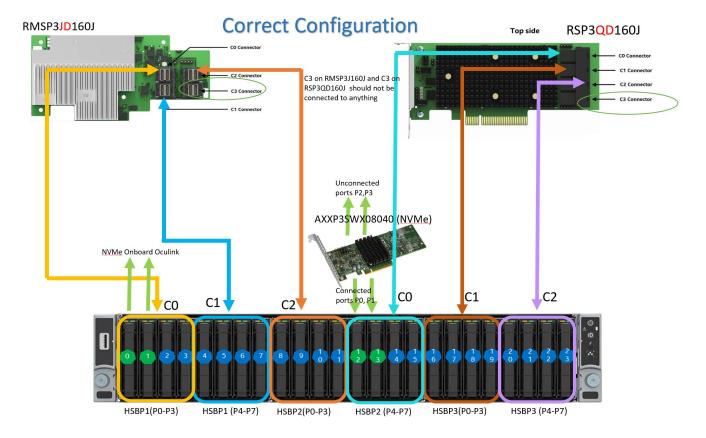
Figure 1. Cable routing for LWF2224NX servers. Green cables/green drives represent NVMe drives for SATA+NVMe configurations.

This was first reported by an Intel customer and the root cause and corrective steps to remediate the problem was determined internally at Intel. Factory instructions for port map cable connections for CO-C1 in RSP3QD160J were incorrect. These have been corrected and addressed, so that factory instructions now contain the correct cabling instructions.

The resolution is to swap the CO-C1 cabling for RSP3QD160J: card port C0 should connect to drive slots 12–15, and card port C1 should connect to drive slots 16–19. Incorrect cabling will have C1 connected to 12-15, C0 connected to drives 16–19. Once these are cabled according to Figure 1, Nutanix\* PRISM hardware diagram will no longer have erroneous display and will report correct drive identifier in case of drive failure.

Use configured AXXCBL800HDHD cable to connect from Controller card connector **C0** to the drive bay 2 SAS/SATA ports 4–7 (route left)

Use configured AXXCBL875HDHD cable to connect from Controller card connector **C1** to the drive bay 3 SAS/SATA ports 0–3 (route right)

Use configured AXXCBL950HDHD cable to connect from Controller card connector **C2** to the drive bay 3 SAS/SATA ports 4–7 (route right)
