Intel® Server Board S2600WF Product Family Intel® Server Board S2600BP Product Family Intel® Server Board S2600ST Product Family

Specification Update

Q3 2022

Intel® Server Boards S2600WF, S2600BP, and S2600ST Products Families Specification Update

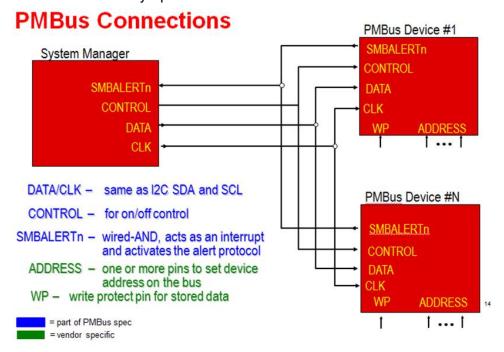
Intel® ME asserts SMLink1 fail health event in SEL sporadically.

Problem Customer may see the following event in the SEL:

This event means that SMLink1 is temporarily unavailable. If there are not SMART/CLST events recorded in the SEL, this is considered a warning, no function is impacted by it and no action needs to be taken.

The root cause is that, in a multi-main PMBus* environment, if a client device holds a Serial Clock Line (SCL) low for too long (exceed TTIMEOUT, defined in PMBus* 1.2 specifications), the Intel® ME will detect the symptom and assert the health event.

If only SMLink1 fail (ER: 04 ST: DC S#: 17 ET: 75 ED: A1 02) is observed in the SEL, it means that SMLink1 is temporarily unavailable. The event is considered a warning, no function is impacted by it and no action needs to be taken.

If both SMLink1 fail (ER:04 ST:DC S#:17 ET:75 ED:A1 02) and SMART/CLST (ER:04 ST:DC S#:B2 ET:03 ED:61 2F 66) are observed in the SEL, the SMLink1 timeouts for exceptional amount of time.

Further system level debug must be performed to figure out the root cause.

Workaround None.
