Intel Technical Advisory

TA-1181

January 20, 2023

RT3EX020E RAID cards shipped with incorrect, Legacy only FW.

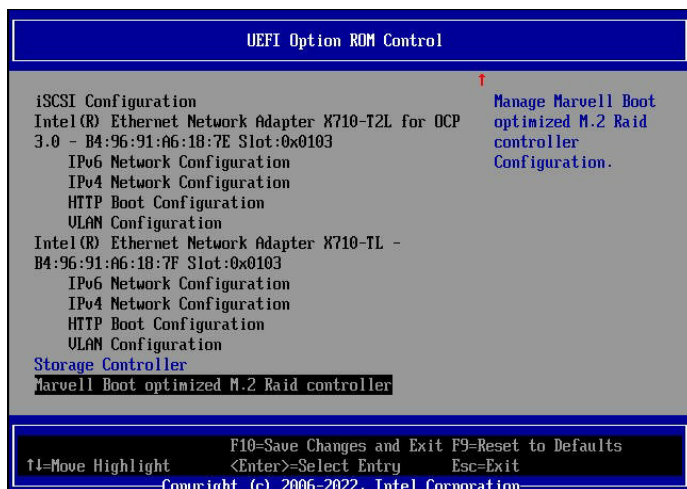
2.3.24.1008 FW

To check what firmware version is installed, in BIOS setup navigate to ADVANCED > PCI Configuration > uEFI Option Rom control and scroll to the bottom of the screen. You should see the Marvell Boot optimized M.2 RAID controller.

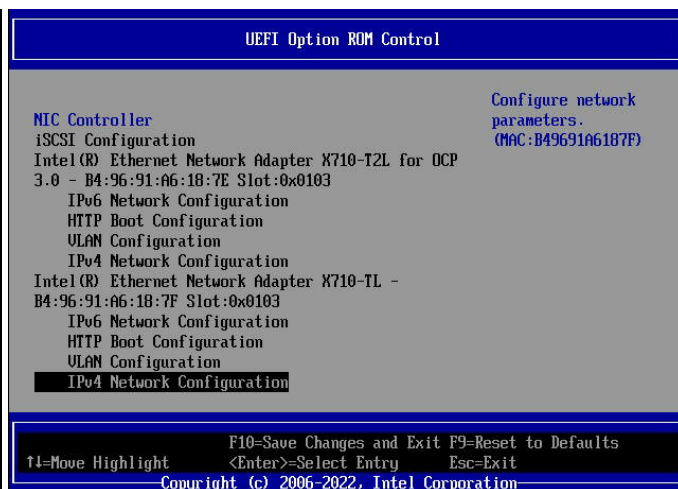
2.3.0.1078 FW

The 2.3.0.1078 firmware lacks the uEFI Hii option ROM interface which allows the RAID card to be configured in BIOS setup. The 2.3.0.1078 firmware only has Legacy option ROM and POST configuration support.

If this screen is not present, the FW needs to be updated to the 2.3.24.1008 FW to allow either Legacy or EFI Hii configuration as determined by the server's operational mode.

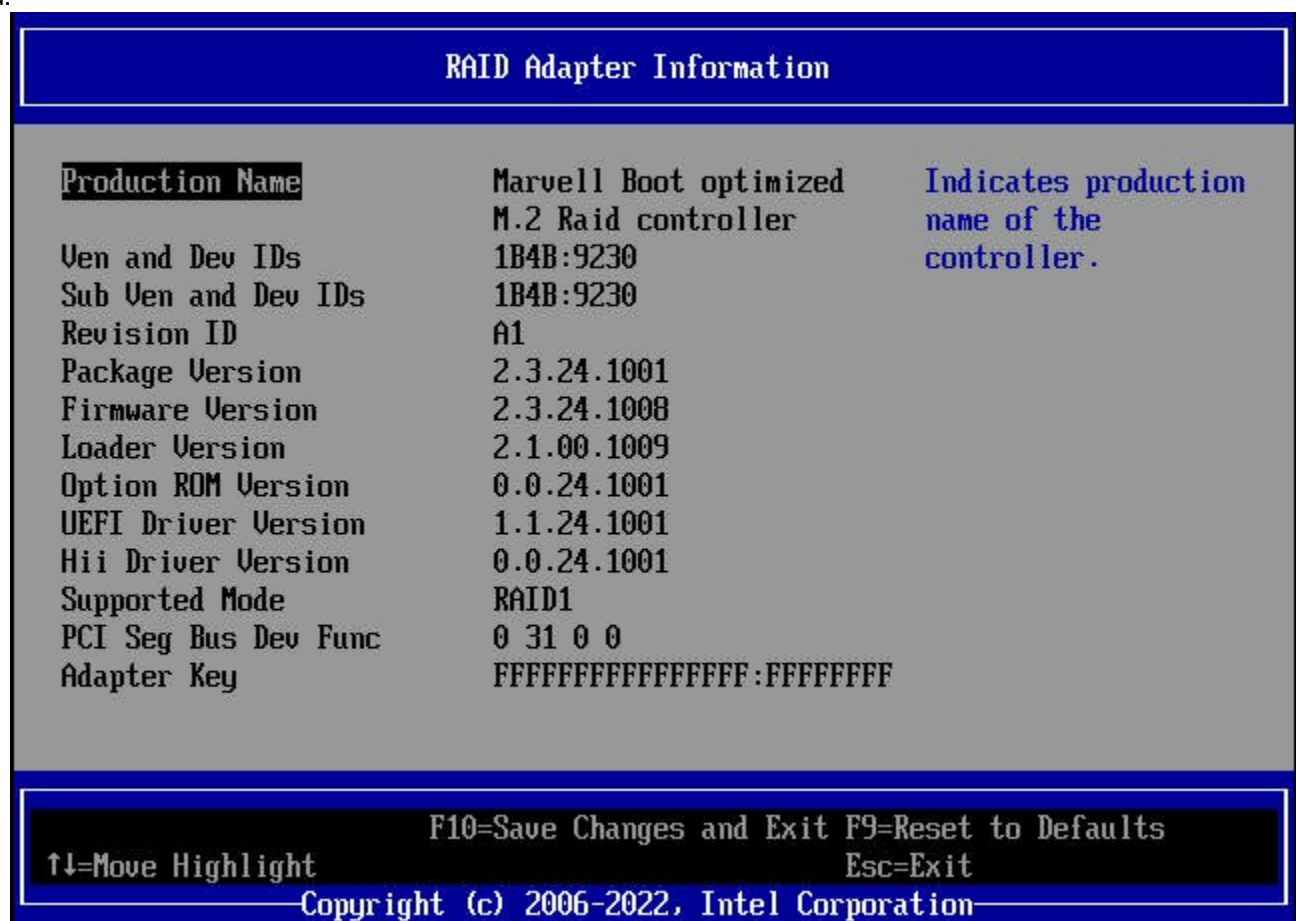
When updated, the firmware level can be displayed by pressing enter at the screen above to confirm the correct FW load.

A FW update package is currently available from Intel Customer Support team.
Web Posting of package is pending.
