This errata sheet provides updated information about known device issues affecting Stratix® IV GT devices.

Production Device Issues for Stratix IV GT Devices

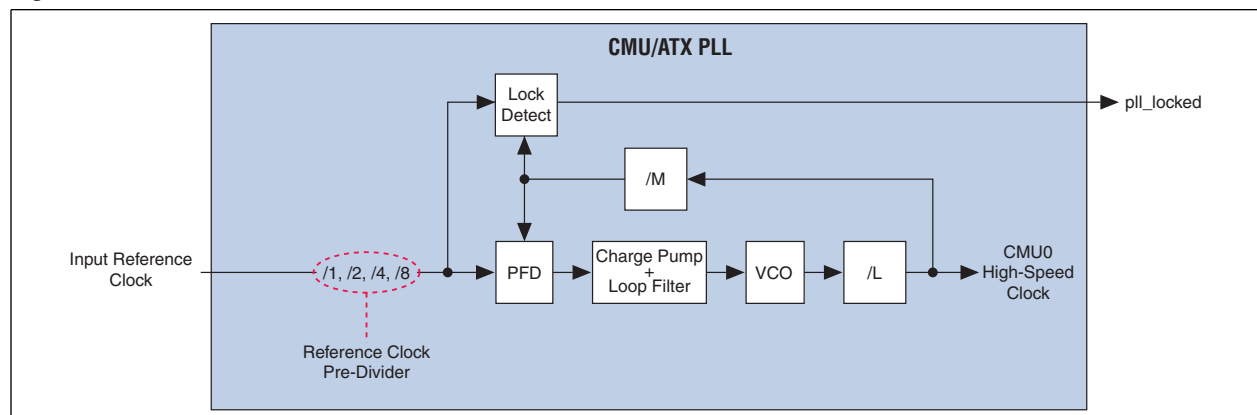
Figure 1. Reference Clock Pre-Dividers in Transmitter PLLs

The transmitter PLL lock status signal (`p11_locked`) does not deassert when the `p11_powerdown` signal is asserted in configurations that use the reference clock pre-divider of 2, 4, or 8. [Figure 1](#) shows the reference clock pre-divider inside transmitter PLLs. This transmitter PLL lock status signal issue impacts the `p11_locked` status signal in both the clock multiplier unit (CMU) PLL and the auxiliary transmit (ATX) PLL.

Designs that implement the recommended transceiver reset sequence described in the [Reset Control and Power Down](#) chapter in volume 2 of the *Stratix IV Device Handbook* could potentially see a link failure after coming out of reset.

If the pll_locked issue impacts your design, instantiate and connect the pll_locked_soft_logic module, as shown in **Figure 3**. You must use the pll_locked_to_corelogic output from this module in the transceiver reset logic and any user logic that relies on the transmitter PLL lock status signal.

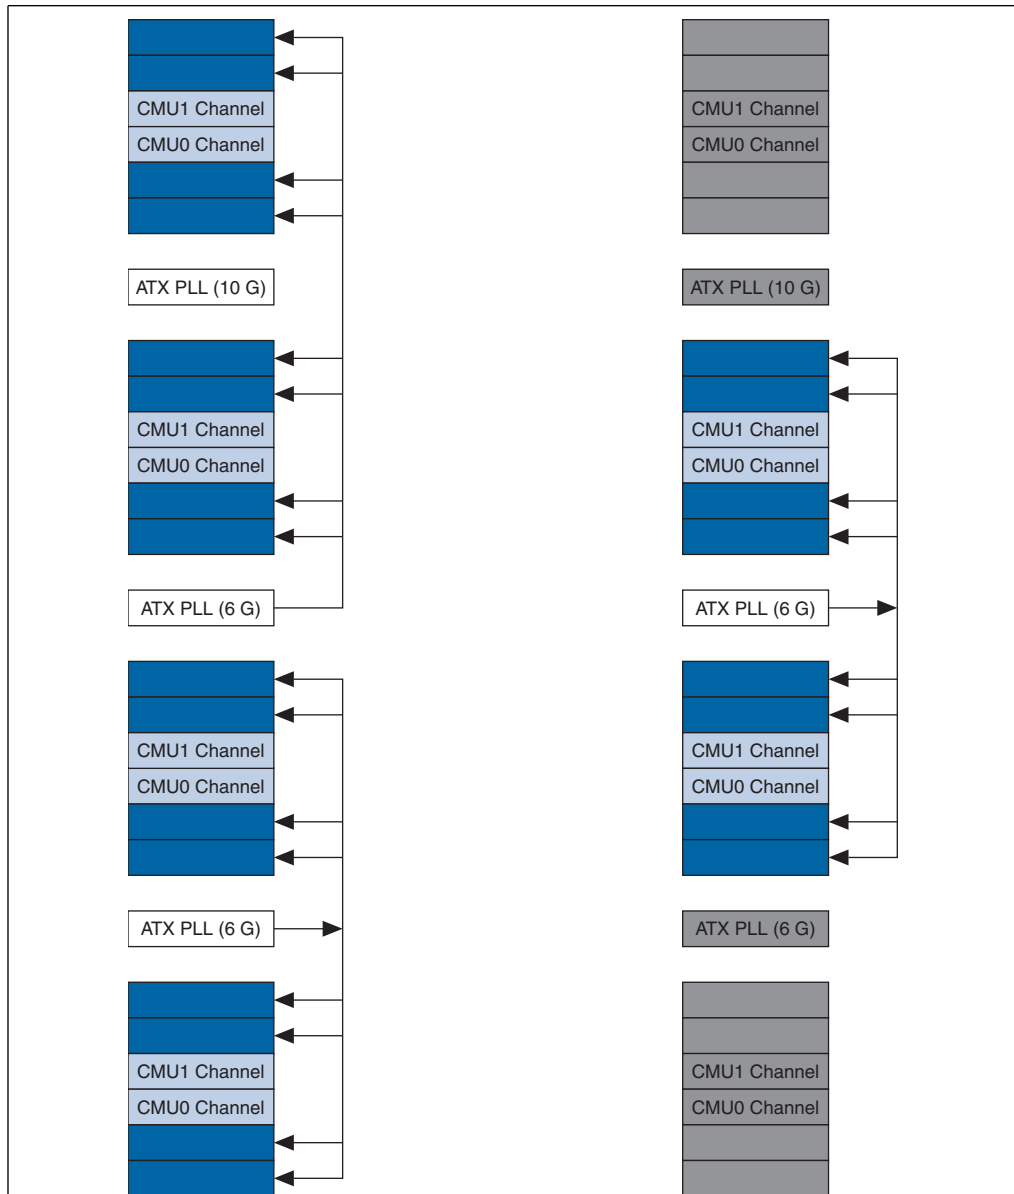
Figure 4. Placement Restrictions in Basic x8 Mode Using ATX PLLs (6G) ⁽¹⁾

(1) This figure shows different instantiations of Basic x8 with the 6G ATX PLL in an EP4S100G5F45 device. The best selection is to use the PLL between the transceiver blocks, but other configurations are possible. The data rate can be as high as 6.5 Gbps as long as the reach is no longer than two transceiver blocks in one direction. For example, the bottom ATX PLL could not drive the top two transceiver blocks at 6.5G, because the top transceiver block is three transceiver blocks away.

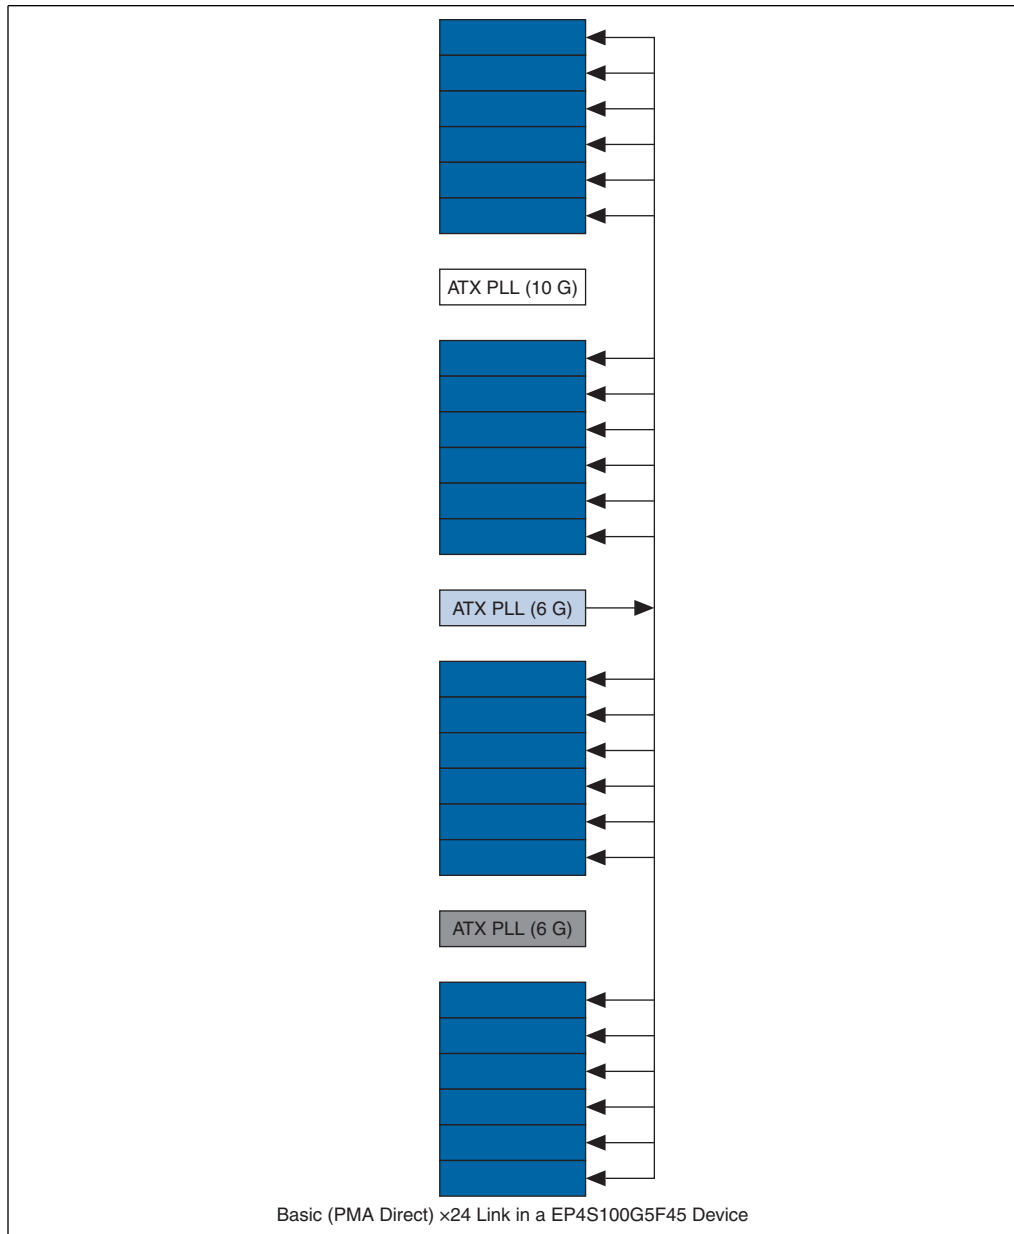
Figure 7. Placement Restrictions in Basic (PMA Direct) xN (N=24) Using ATX PLLs (6G)

ALTGX Functional Mode	TX PLL Type	Bonding	Supported Data Rates		Placement Restrictions
			Speed Grade	Max Data Rate (Gbps)	
Basic x1 and Basic x4	ATX PLL (6G)	Up to x4	All ⁽¹⁾	6.5	It is best to use the ATX PLL (6G) adjacent to the transceiver block where the channels are located. For more information, refer to Figure 5 on page 13 . The maximum distance away from the ATX PLL is two transceiver blocks.
Basic x8	CMU PLL	Up to x8	All	6.5	—
	ATX PLL (6G)	Up to x8	All ⁽¹⁾	6.5	It is best to use the ATX PLL (6G) between the two transceiver blocks. For more information, refer to Figure 4 on page 12 . The maximum distance away from the ATX PLL is two transceiver blocks.
Basic xN (PMA Direct)	CMU PLL	Up to x17	All	6.5	Bonded channels must be contiguous. You must use the CMU PLL in the middle transceiver block. For more information, refer to Figure 6 on page 14 .
		> x17	All	3.25	—
	ATX PLL (6G)	Up to x24	All ⁽¹⁾	6.5	You must use ATX L1 PLL (6G) for left-side bonding. You must use ATX R1 PLL (6G) for right-side bonding. For more information, refer to Figure 7 on page 15 .

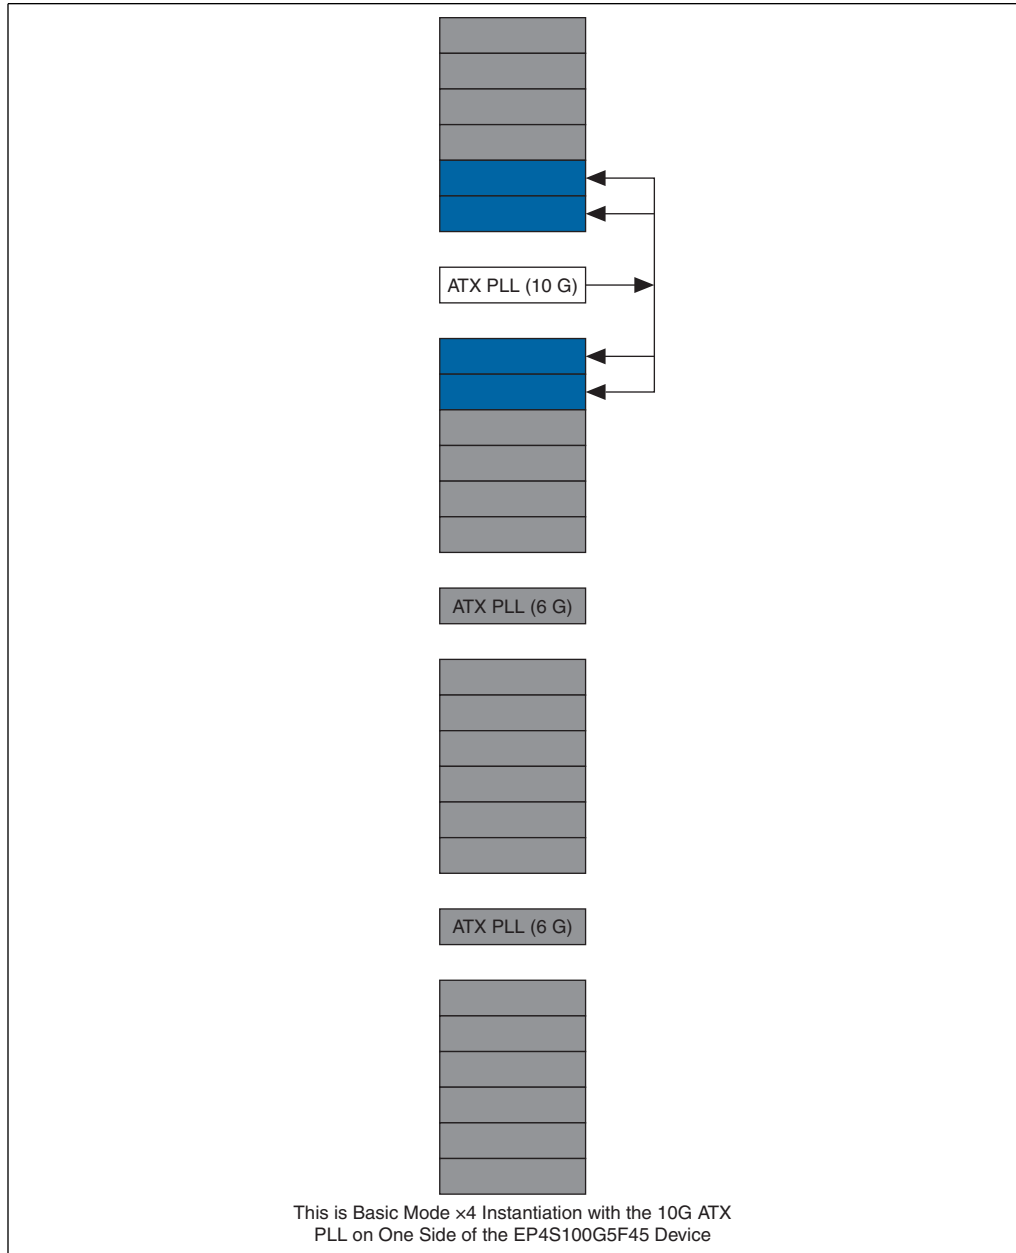
Figure 8. Placement Restrictions in Basic x1 and Basic x4 Mode Using ATX PLLs (10G)

ALTGX Functional Mode	TX PLL Type	Bonding	Supported Data Rates		Placement Restrictions
			Speed Grade	Max Data Rate (Gbps)	
Basic x1 and Basic x4	ATX PLL (10G)	Up to x4	All ⁽¹⁾	10.3	You must use the ATX PLL (10G) between the two transceiver blocks used. The ATX PLL (10G) can support the two channels just above and the two channels just below. For more information, refer to Figure 8 on page 16 .

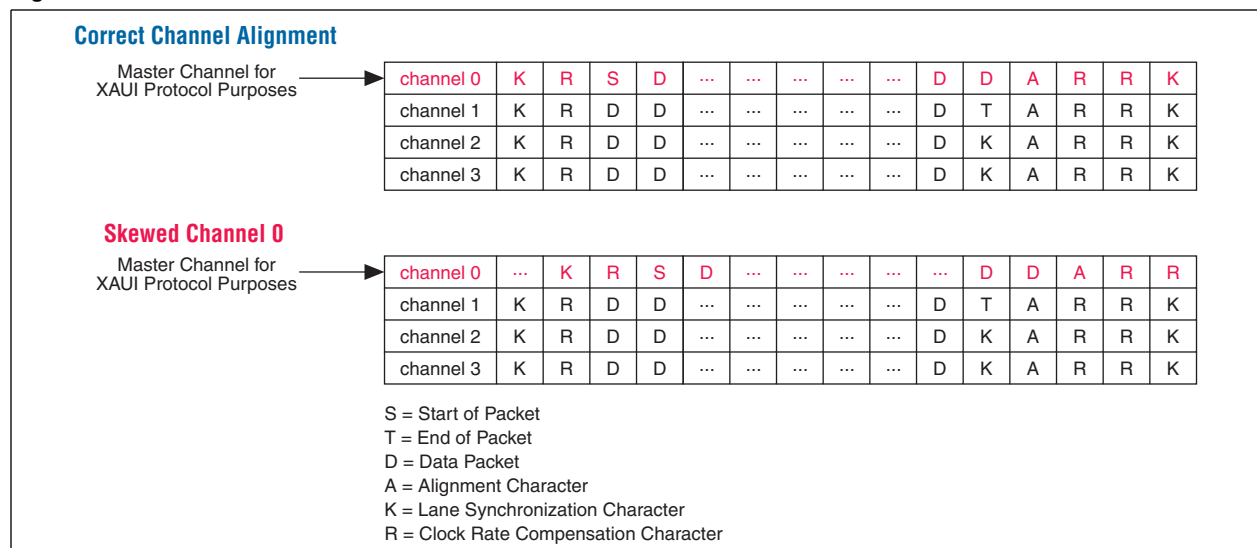
Figure 9. Rate Match FIFO Skew

In XAUI functional mode, the data out of the physical transceiver channel 0’s Rate Match FIFO may be shifted by one byte with respect to the data of the other three channels. This shifting causes incorrect idle ordered set conversion, resulting in incorrect received parallel data. The corrupted received parallel data caused by improper idle ordered set conversion or rate matcher corruption happens only during initialization or receiver channel reset (assertion of rx_analogreset or rx_digitalreset).

Figure 9 shows the channel skew.

Altera provides a soft IP solution and associated documentation, available for download at: www.altera.com/patches/xauip-softip/xauip-softip-fix-reva.zip

Integrate this soft IP into the XAUI receiver data path. Altera will fix this issue on production devices.
