This errata sheet provides updated information about known device issues affecting Stratix® IV GX devices.

## Production Device Issues for Stratix IV GX Devices

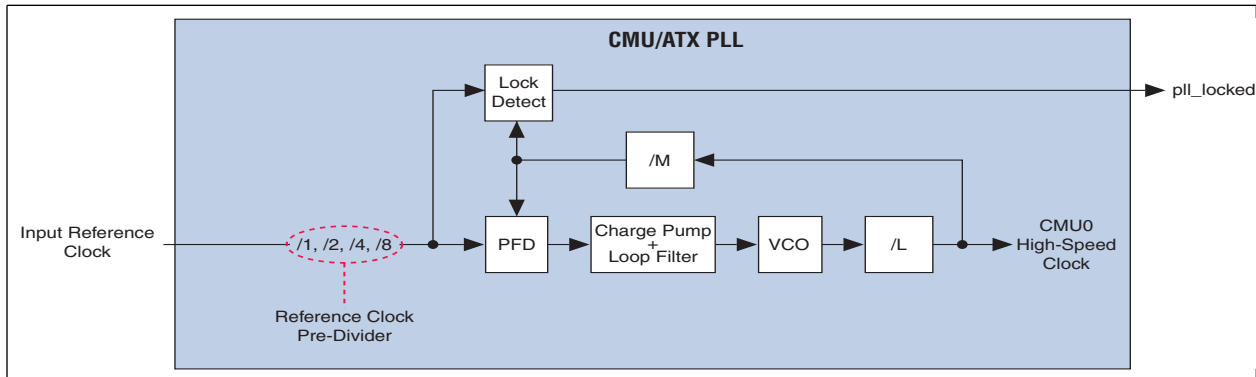
Figure 1. Reference Clock Pre-Dividers in Transmitter PLLs

The transmitter PLL lock status signal (pll\_locked) does not deassert when the pll\_powerdown signal is asserted in configurations that use the reference clock pre-divider of 2, 4, or 8. Figure 1 shows the reference clock pre-divider inside transmitter PLLs. This transmitter PLL lock status signal issue impacts the pll\_locked status signal in both the CMU PLL and the ATX PLL.

If the `pll_locked` issue impacts your design, instantiate and connect the `pll_locked_soft_logic` module, as shown in Figure 3. Use the `pll_locked_to_corelogic` output from this module in the transceiver reset logic and any user logic that relies on the transmitter PLL lock status signal.

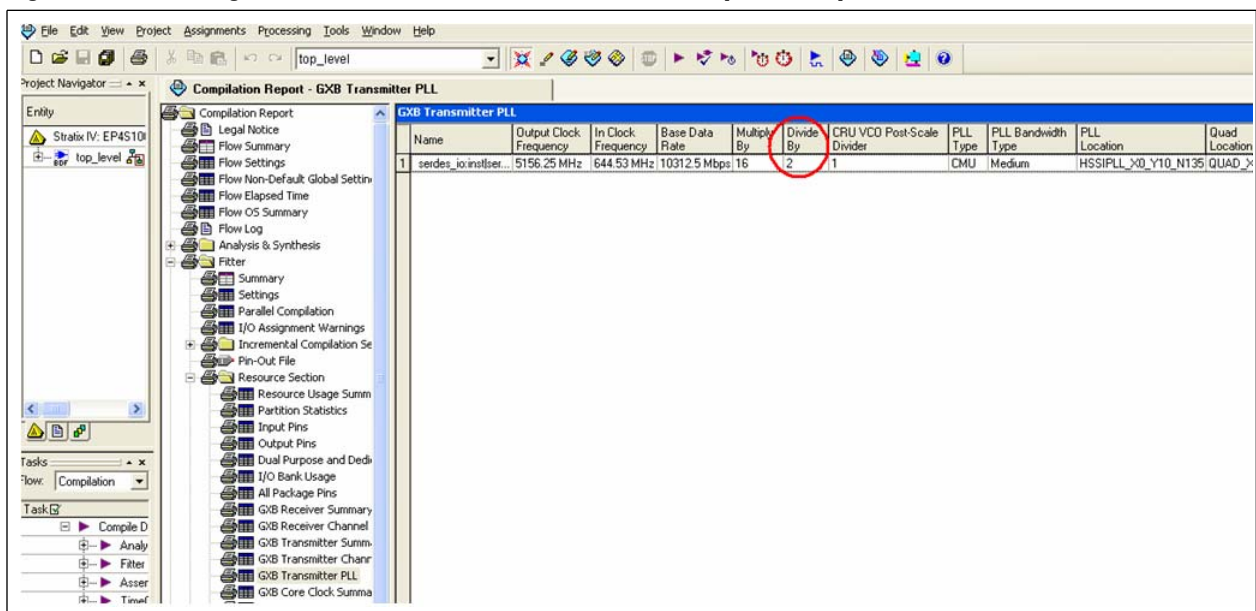
Figure 2. Determining Reference Clock Pre-Divider Value in the Compilation Report

You can determine whether the Transmitter PLL in your design uses a reference clock pre-divider of 2, 4, or 8 by referring to the Quartus II software Compilation Report. Figure 2 shows an example of the GXB Transmitter PLL report, which you find in the “Resources Section” under “Fitter” in the Compilation Report. If the value in the **Divide By** column reads 2, 4 or 8, your design is impacted by the pll\_locked status signal issue.

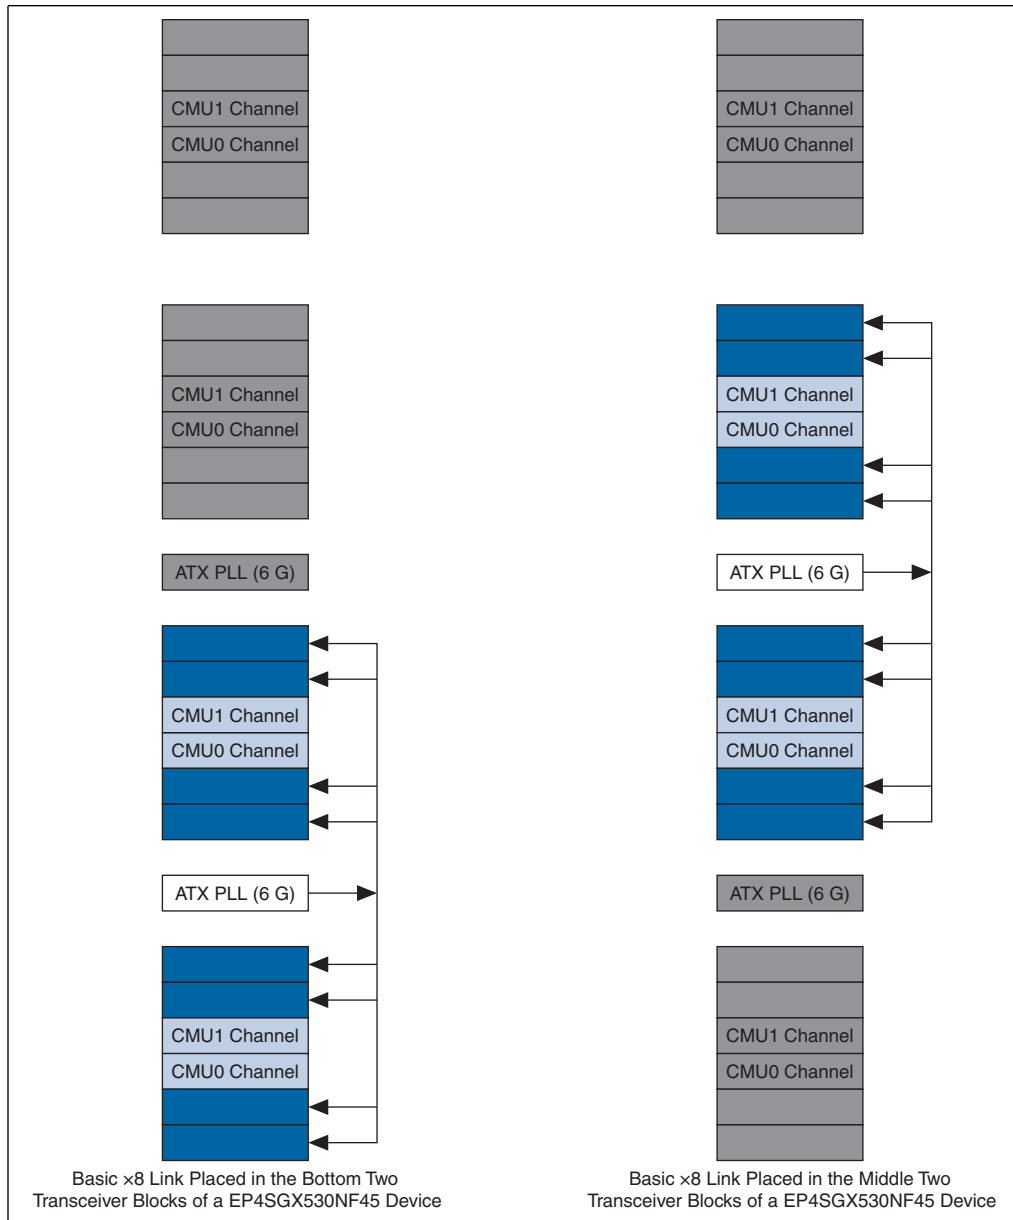
**Figure 4. Placement Restrictions in Basic x8 Mode using ATX PLLs (6G)**

The xN clock line timing issue in Stratix IV GX production devices affects the maximum data rate supported in the following transceiver configurations:

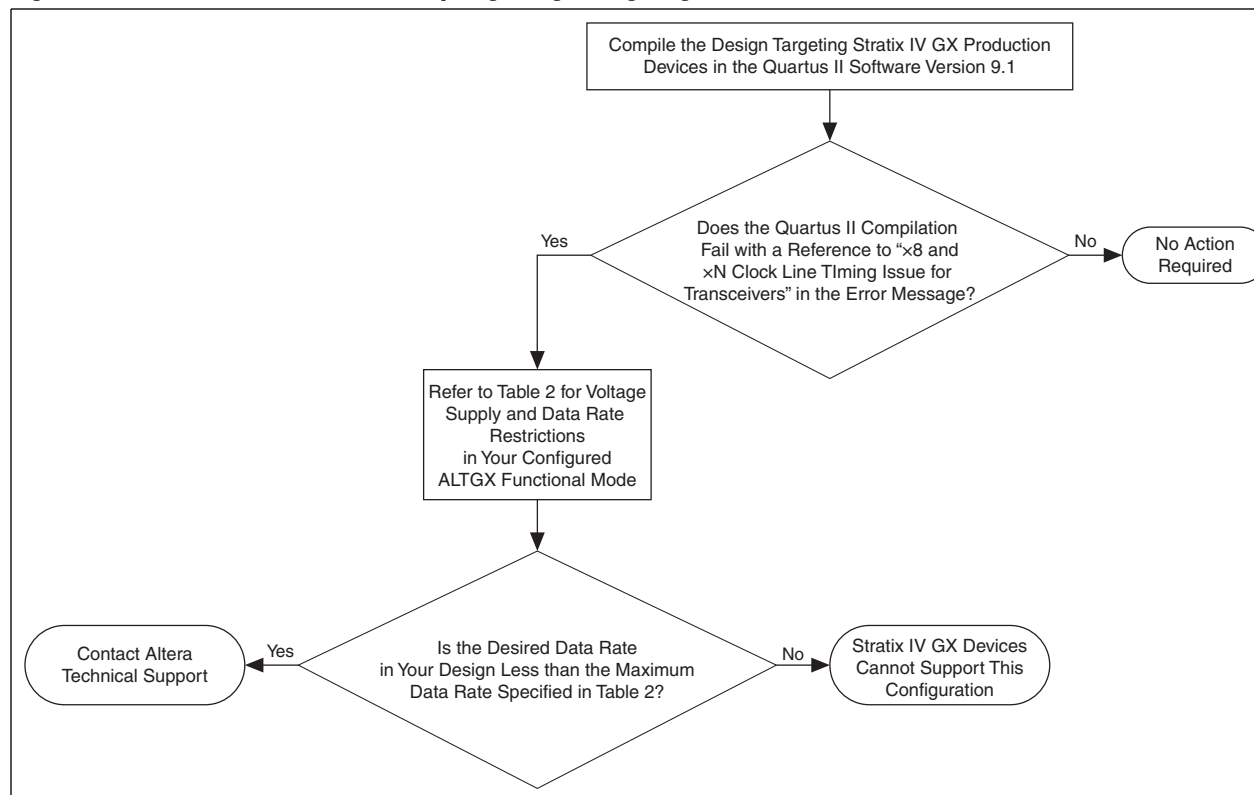
**Figure 8. Recommended Flow When Compiling Designs Targeting Stratix IV GX Production Devices**

For Stratix IV GX production devices, the Quartus II software version 9.1 does not implement the correct data rate restrictions shown in [Table 2](#).

Follow the recommended flow in [Figure 8](#) when you compile designs with the Quartus II software version 9.1 that target Stratix IV GX devices.

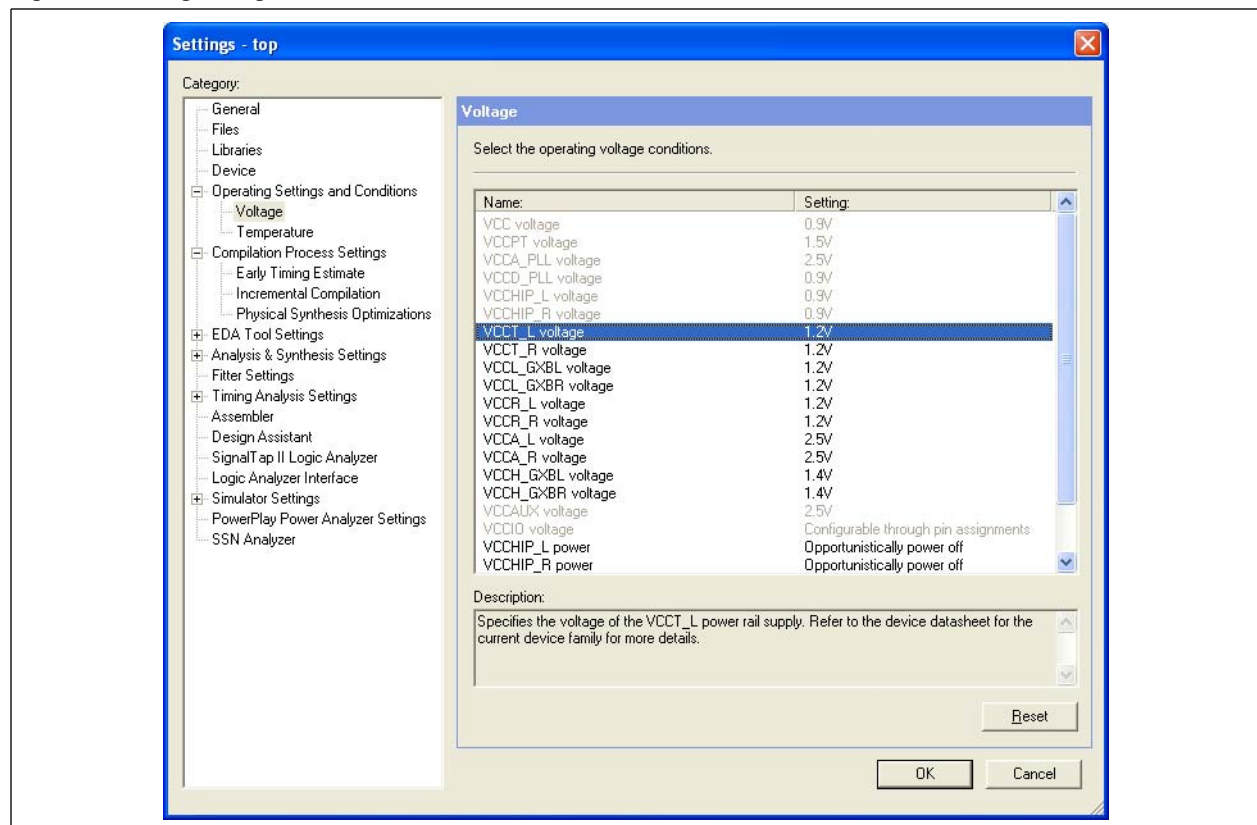
**Figure 9. Setting Voltage Levels**

- **Category 2:** The configured xN line data rate is greater than the maximum data rate supported by 1.1 V, but less than or equal to that supported by the 1.2-V power supply level specified in [Table 2](#).

Action: In the Quartus II software, on the Assignments menu, click **Settings**. Click the "+" icon to expand **Operating Settings and Conditions** and select **Voltage**. Set the **VCCT\_L/R**, **VCCL\_GXBL/R**, and **VCCR\_L/R** voltage settings from **1.1V** to **1.2V**, as shown in [Figure 9](#). Then recompile the project.

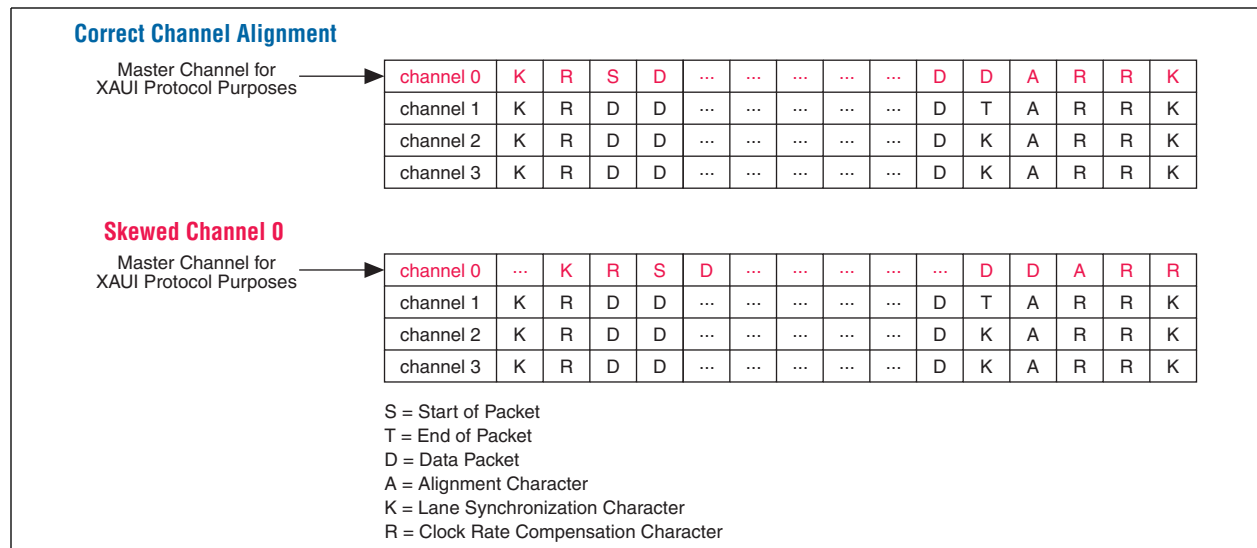
**Figure 10. Rate Match FIFO Skew**

In XAUI functional mode, the data out of the physical transceiver channel 0's Rate Match FIFO may be shifted by one byte with respect to the data of the other three channels. This shift causes incorrect idle ordered set conversion, resulting in incorrect received parallel data. The corrupted received parallel data caused by improper idle ordered set conversion or rate matcher corruption happens only during initialization or receiver channel reset (assertion of rx\_analogreset or rx\_digitalreset).

Figure 10 shows the channel skew.

Altera provides a soft IP solution and associated documentation, available for download at: [www.altera.com/patches/xau-softip/xau-softip-fix-reva.zip](http://www.altera.com/patches/xau-softip/xau-softip-fix-reva.zip)

Integrate this soft IP into the XAUI receiver data path.
