Intel Atom[®] Processor E3800

Specification Update

(Formerly Bay Trail -I SoC)

October 2017

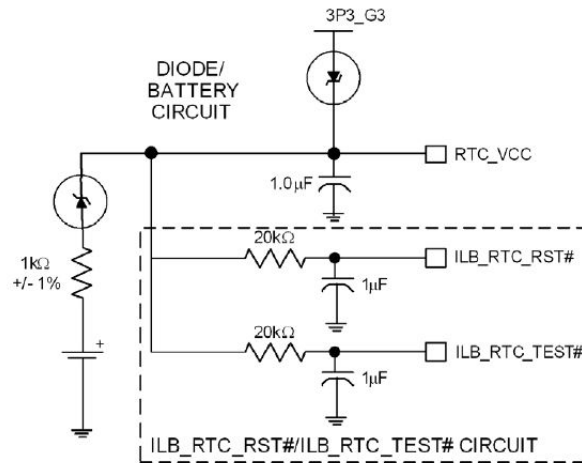
2. ILB_RTC_TEST# and ILB_RTC_RST# RC Time Delay Calculation Formula

The RC delay between RTC_VCC to ILB_RTC_TEST and ILB_RTC_RST, Figure 21-4 in Section 21.2.3 of the PDG (Doc ID #512379) is obtained by using the formula $t = -\ln((RTC_VCC - V_{ih\ min})/RTC_VCC) * R * C$ and the added circuit is as follows:

The SoC RTC requires some additional external circuitry. The ILB_RTC_RST# and ILB_RTC_TEST# signals are used to reset the RTC well. The external capacitor and the external resistor between ILB_RTC_RST#/ILB_RTC_TEST# and RTC battery (VBAT) were selected to create an RC time delay, such that ILB_RTC_RST# and ILB_RTC_TEST# go high sometime after the battery voltage is valid. The RC time delay should be in the range of 18-25 ms. When ILB_RTC_TEST# is asserted, bit 2 (RTC_PWR_STS) in the GEN_PMCON_1 (General PM Configuration 1) register is set to 1, and remains set until software clears it. Hence, when the system boots, the BIOS recognizes that the RTC battery is removed.
