# **Intel® Xeon® Processor D-1500 Product Family and Intel® Xeon® Processor D-1500 NS Product Family**

**Specification Update**

***February 2018***

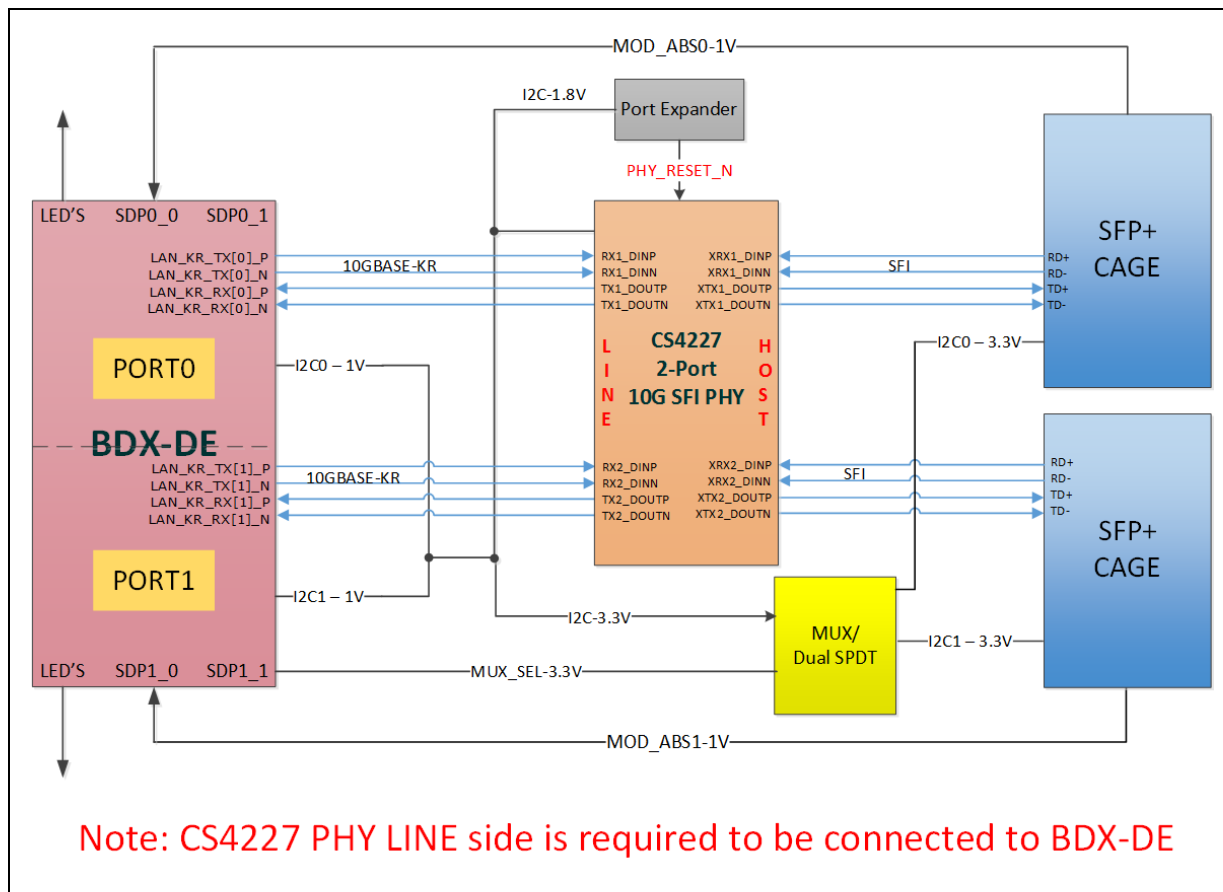
- Figure 9-4 is replaced with the following figure. The original had incorrect labels on the KR interface. The RX and TX pairs were swapped on Broadwell-DE.

## 4. Grangeville with the *Intel® Xeon® Processor D-1500 Product Family Platform Design Guide* (document number 543448) change.
