Intel® Xeon® Processor E5 Product Family

Specification Update

May 2020

Revision 021

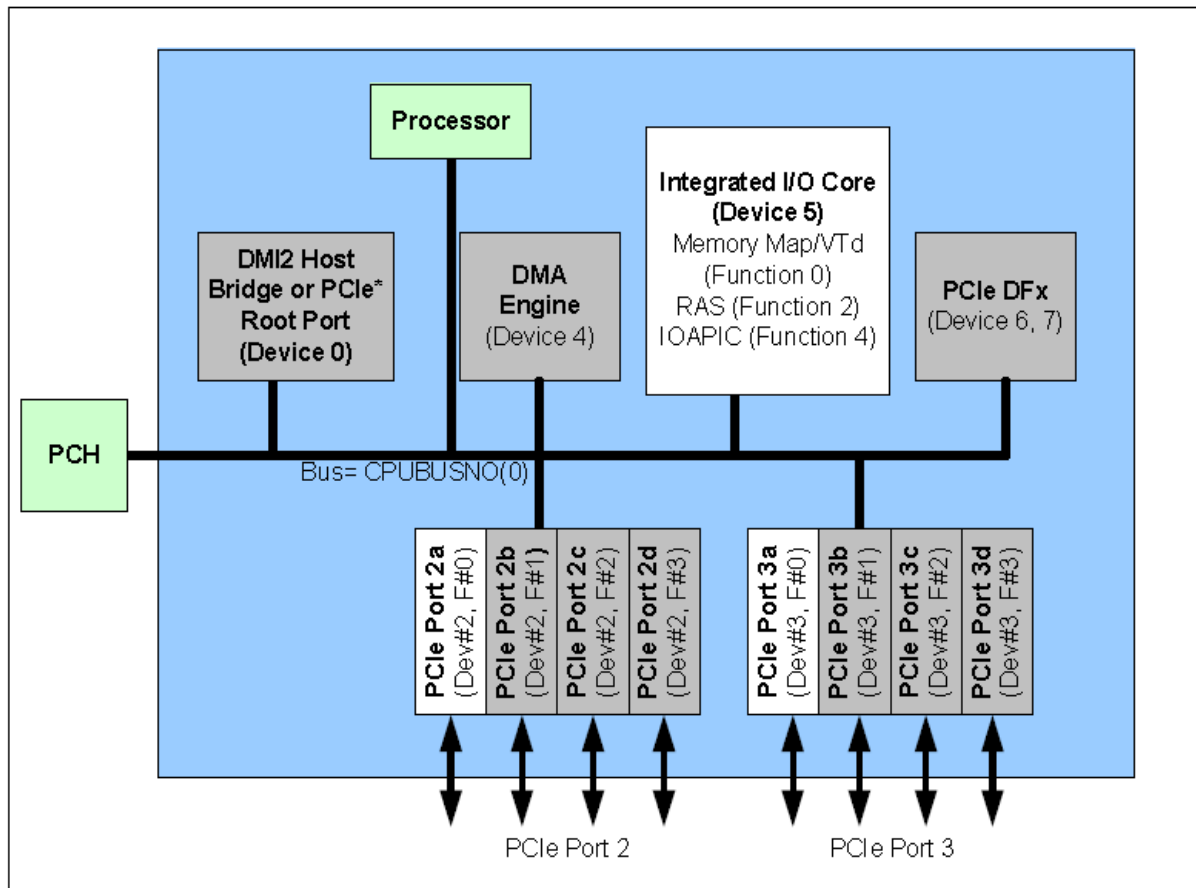
The drawing in the current document does not include devices 6 and 7. These are internal devices not generally accessible on production systems. The drawing below is correct.

Device 6, 7: PCI Express Dfx. Contains the PCI Express debug (DFx), Lock, Error Inject Registers.
