# Intel<sup>®</sup> Xeon<sup>®</sup> Processor C5500/ C3500 Series

**Specification Update**

April 2012

Order Number: 323105, Revision: -020

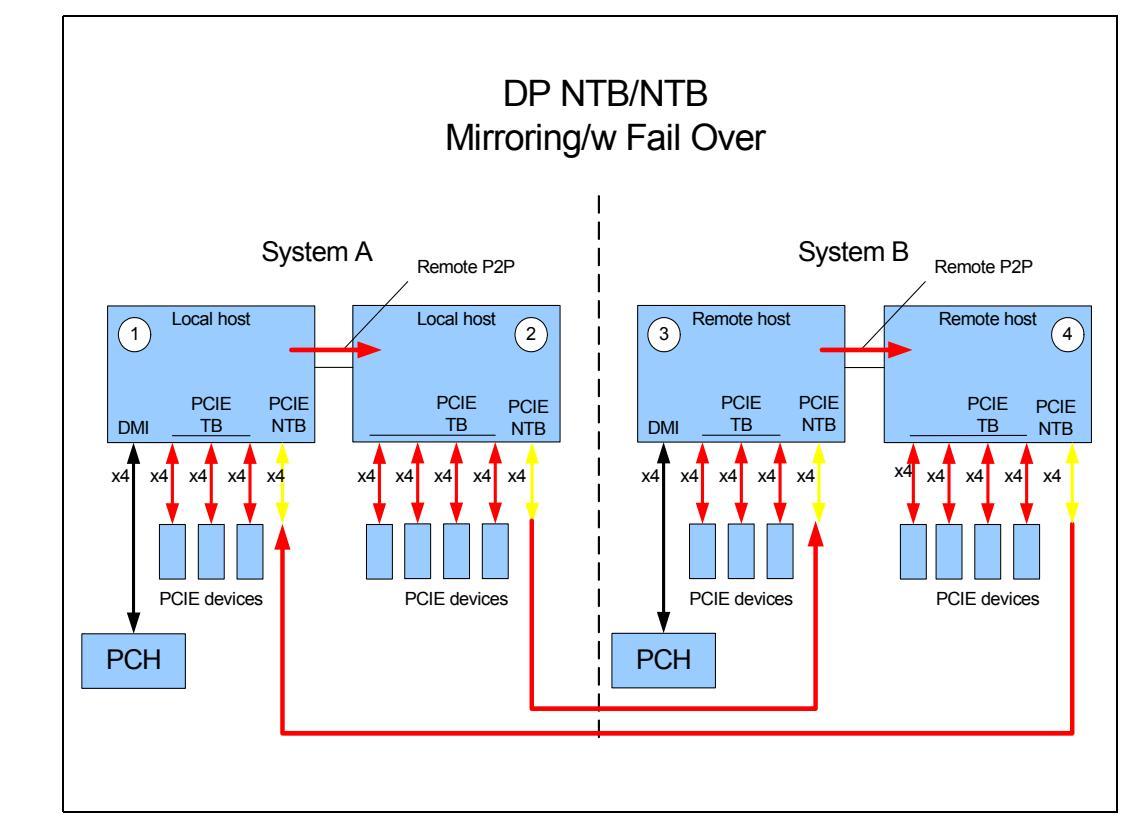
#### Figure 60. DP with Dual NTB Links Deadlock

3. Dev3 (NTB) wants to request to memory, but no ORBs are available for RFO (posted prefetch). Device 4 and Device 6 are requesting to local memory and remote p2p. They have already sent RFOs and are holding onto the ORBs, but the ORBs cannot be released until the write data is sent to memory. For both devices, the write data to memory is blocked by a remote p2p request at the top of the queue. The remote p2p is blocked due to blockage in IIO-1.

4. NCBs from CPU and IIO-0 are blocked due to Device 3 (NTB) outbound write queue being full.

If this case is created deadlock will occur. A workaround is needed to remove the full system closed loop posted to posted dependencies.
