Intel[®] I/O Controller Hub 7 (ICH7) Family

Intel[®] ICH7 Family Specification Update

May 2012

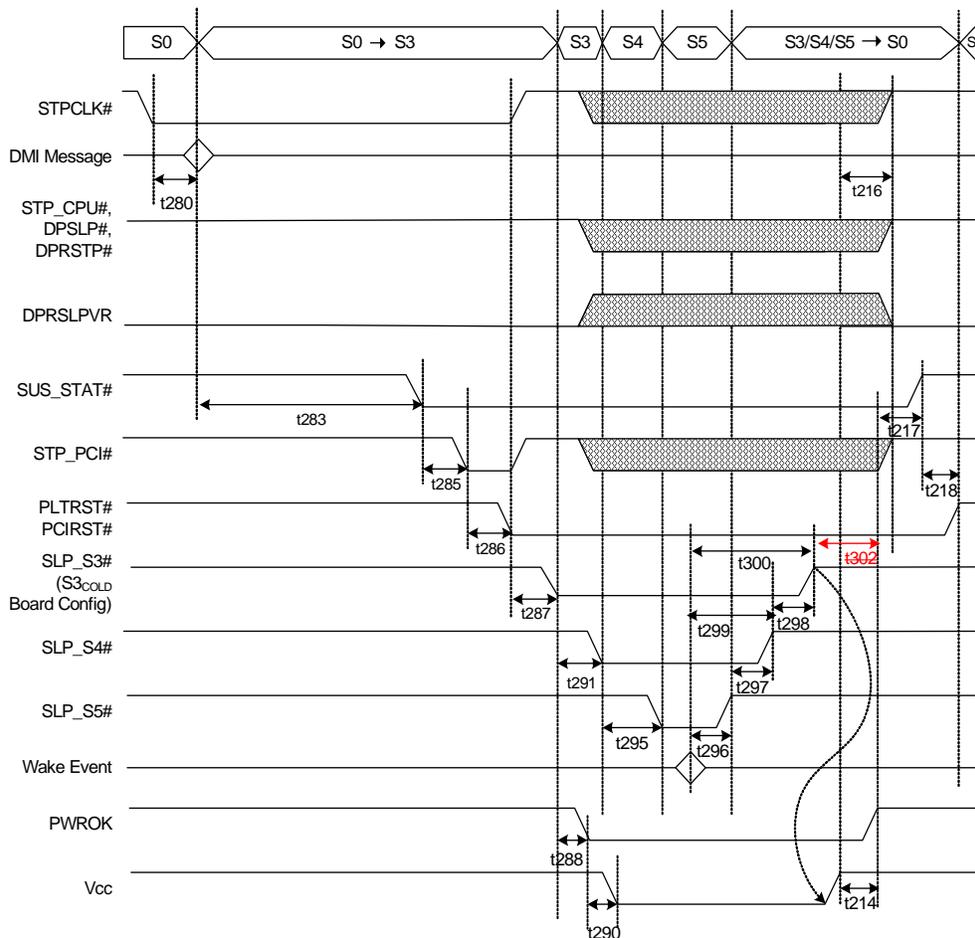
Figure 23-25 S0 to S5 to S0 Timings, S3_cold (Mobile/Ultra Mobile Only)

Remove the t302 timing requirement from Figure 23-25 S0 to S5 to S0 Timing, S3_cold (Mobile/Ultra Mobile Only) in the Datasheet.
