# Monthly Specification Update

***Intel® Server Board S3420GP***

*Intel Order Number E82362-009*

**December 2011**

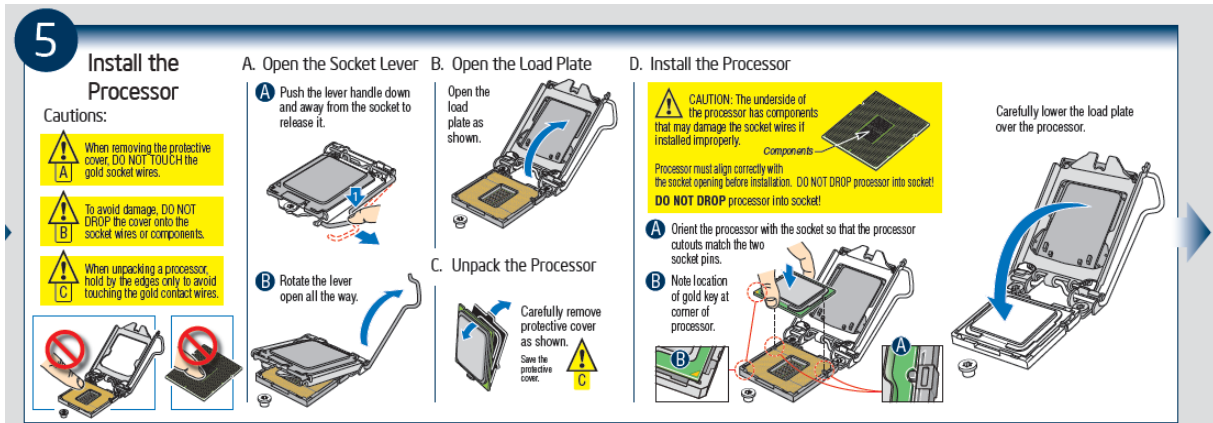
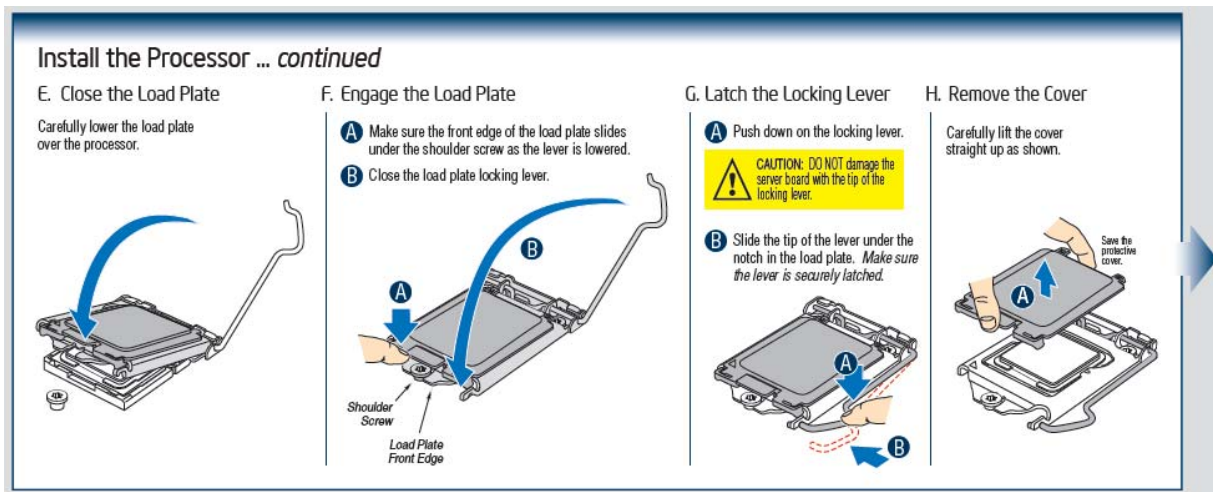
Figure 2. Post Change Installation Procedure

## 6. Intel® Server Board S3420GP Quick Start User Guide update for the processor socket protective cover change

Implication To reflect the processor socket protective cover change, the following step will be the post-change installation procedure.
