This errata sheet provides updated information about known device issues affecting Stratix® IV GT devices.

Production Device Issues for Stratix IV GT Devices

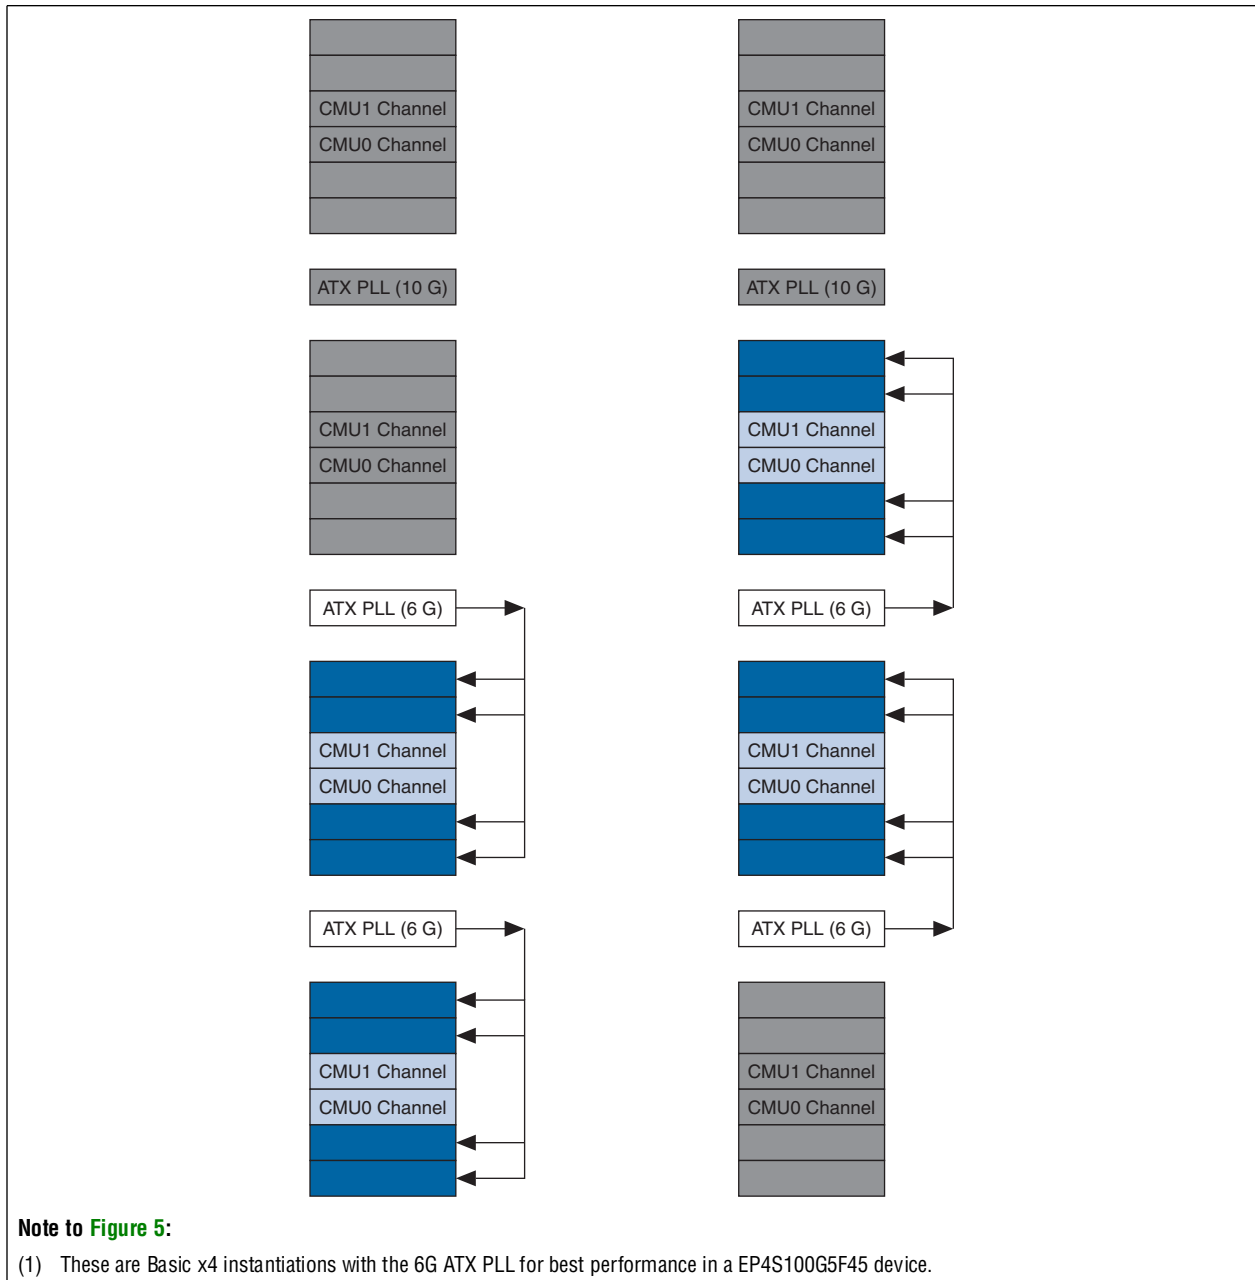
Figure 5. Placement Restrictions in Basic x1 and Basic x4 Mode Using ATX PLLs (6G) ⁽¹⁾

ALTGX Functional Mode	TX PLL Type	Bonding	Supported Data Rates		Placement Restrictions
			Speed Grade	Max Data Rate (Gbps)	
Basic x1 and Basic x4	ATX PLL (6G)	Up to x4	All ⁽¹⁾	6.5	It is best to use the ATX PLL (6G) adjacent to the transceiver block where the channels are located. For more information, refer to Figure 5 on page 13 . The maximum distance away from the ATX PLL is two transceiver blocks.
Basic x8	CMU PLL	Up to x8	All	6.5	—
	ATX PLL (6G)	Up to x8	All ⁽¹⁾	6.5	It is best to use the ATX PLL (6G) between the two transceiver blocks. For more information, refer to Figure 4 on page 12 . The maximum distance away from the ATX PLL is two transceiver blocks.
Basic xN (PMA Direct)	CMU PLL	Up to x17	All	6.5	Bonded channels must be contiguous. You must use the CMU PLL in the middle transceiver block. For more information, refer to Figure 6 on page 14 .
		> x17	All	3.25	—
	ATX PLL (6G)	Up to x24	All ⁽¹⁾	6.5	You must use ATX L1 PLL (6G) for left-side bonding. You must use ATX R1 PLL (6G) for right-side bonding. For more information, refer to Figure 7 on page 15 .
