Dual-Core Intel[®] Xeon[®] Processor 3000 Series

Specification Update

February 2008

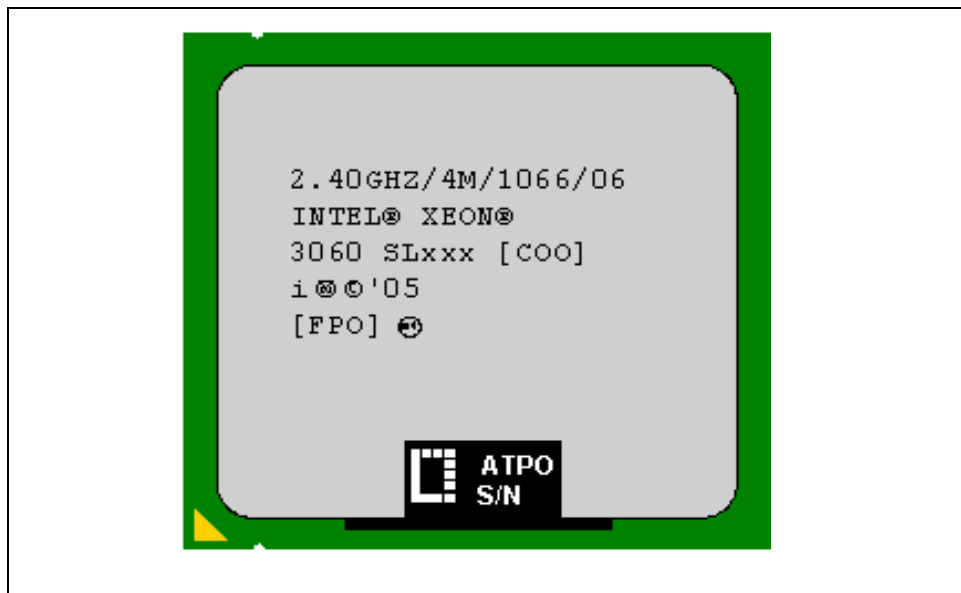
Figure 2. Processor Top-Side Markings Example for the Dual-Core Intel® Xeon® Processor 3000 Series with 4MB L2 Cache with 1066 MHz FSB
