# Intel® Xeon® Processor 5200 Series

## Specification Update

*June 2009*

Order Number: 318586-017

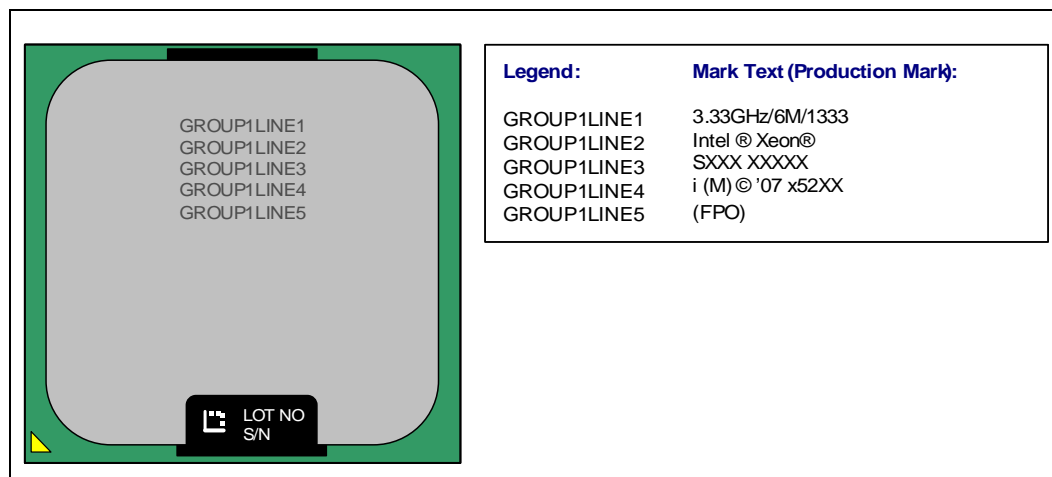
**Figure 1. Processor Top-side Markings (Example)**

Intel® Xeon® Processor 5200 Series stepping can be identified by the following component markings:
