Intel[®] Ethernet Controller I350 Specification Update

Revision: 2.04
January 2012

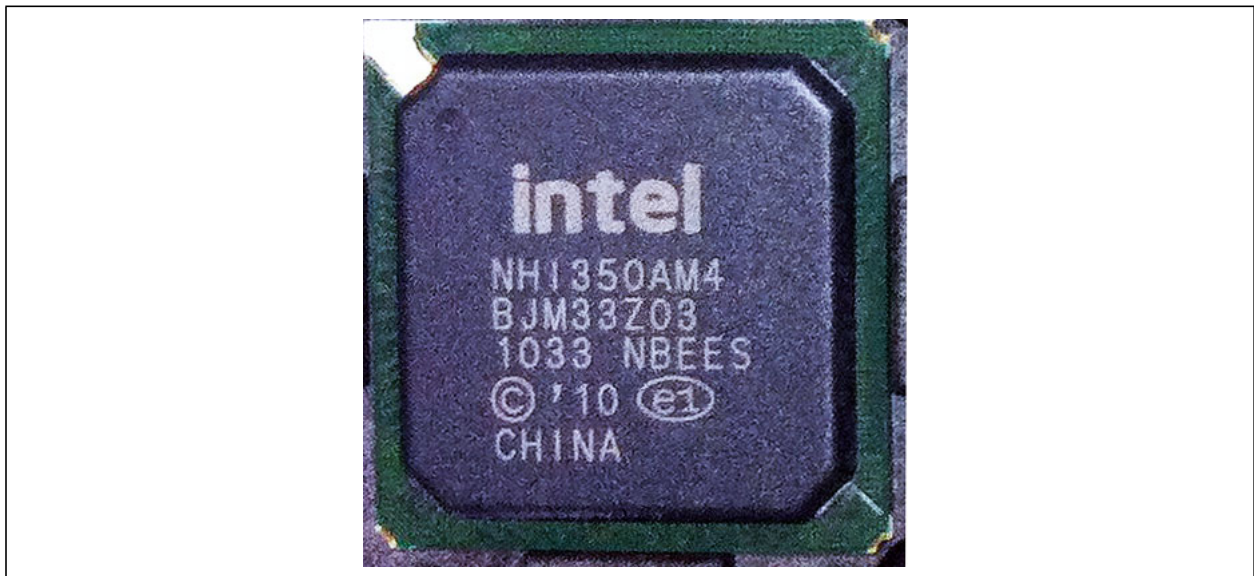
Figure 1-1. Example Component With Identifying Marks

Line 1	“intel”
Line 2	Marketing Name
Line 3	Fab Lot Number “XXXXXXXX” (Wafer Lot no. concatenated with Assembler vendor code)
Line 4	Assembly Date Code YYWW; Engineering samples have additional Intel data.
Line 5	Copyright line; includes two number date code and the Pb-free mark (e1)
Line 6	Country of Origin
