Intel[®] Xeon[®] Processor 7100 Series

Specification Update

Order Number: 314554-005

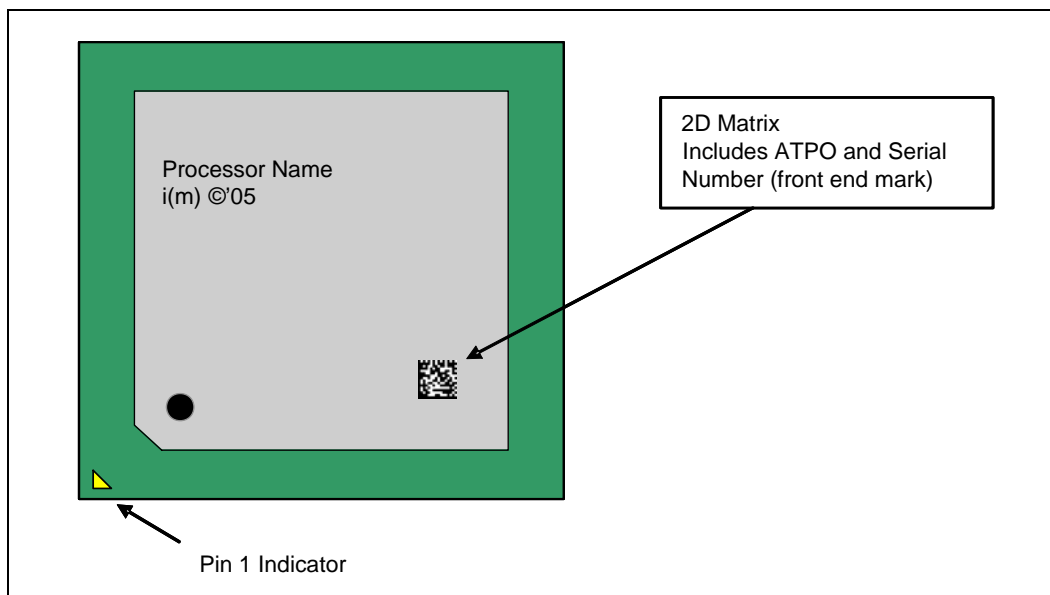
Figure 1. Processor Top-Side Markings (Example)

Dual-Core Intel® Xeon® Processor 7100 Series Package Markings

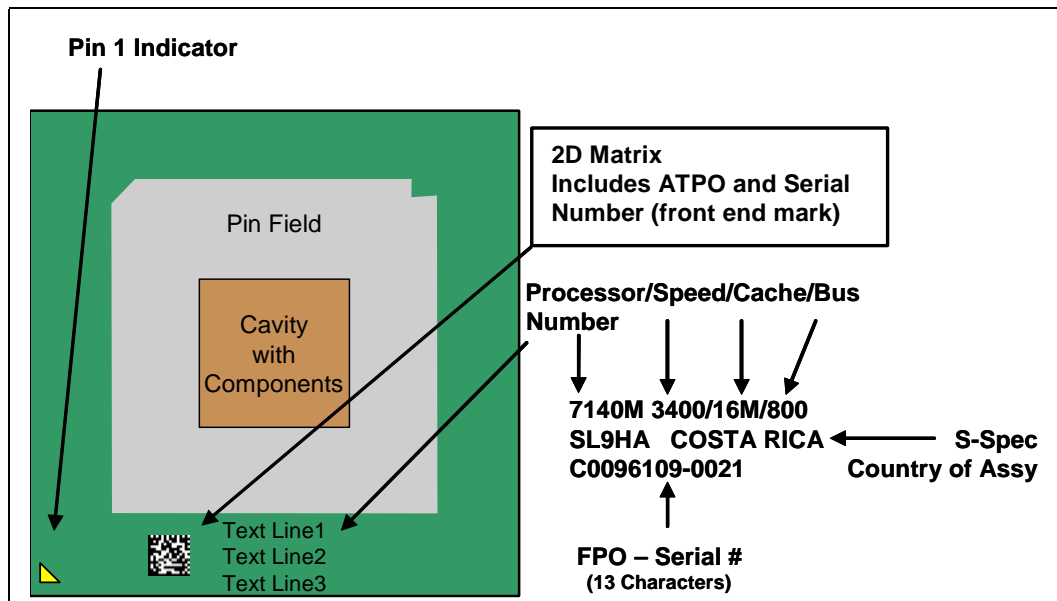
Figure 4-5. Processor Bottom-Side Markings has been updated to include a 2D Matrix.
